# Conservation Management Plan

## Maryborough Municipal Olympic

### Swimming Pool Complex

**April 2018**

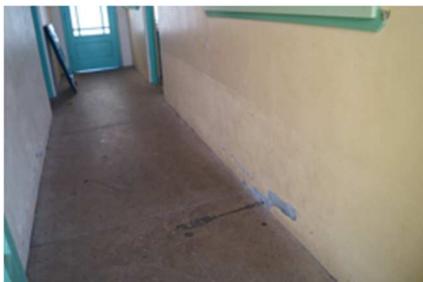
The internal wall clearly shows the line of new render repairs and also the height at which the salts rise in the wall before coming out of the brickwork. The First Aid Room is on the left of the public passage.

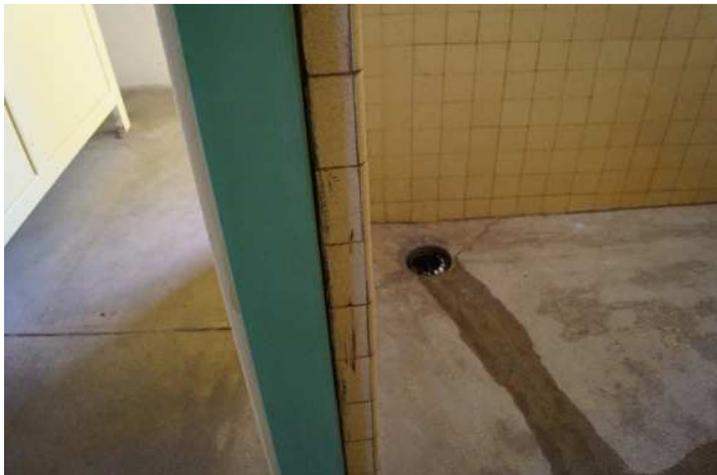
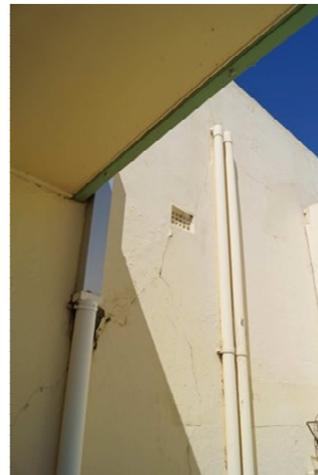
View of the continual water leak in the shower recess in the Men's Changing Room and damage caused to the floor waste. Evidence of both internal and external cracking at the entrance to the Men's Changing Rooms.

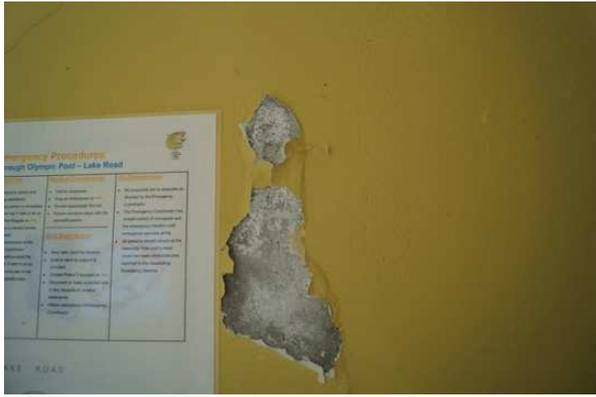
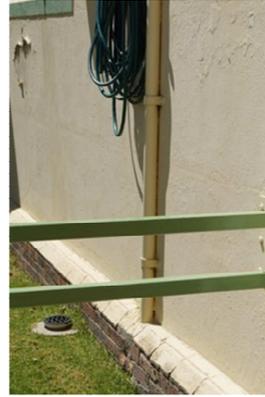
The damp wall showing efflorescence salts is directly behind the external downpipe and water hose.

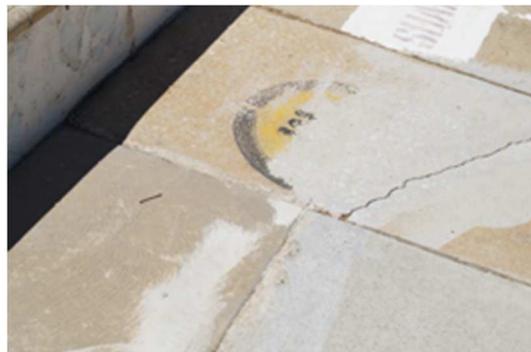
Detail showing successive repairs to the paving.

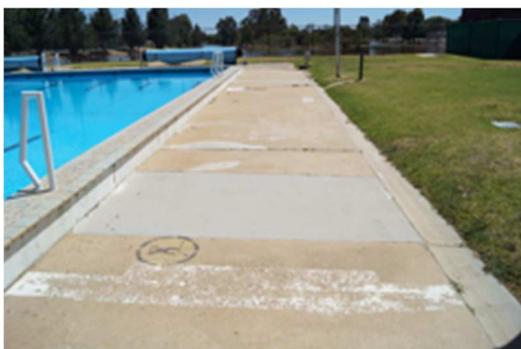
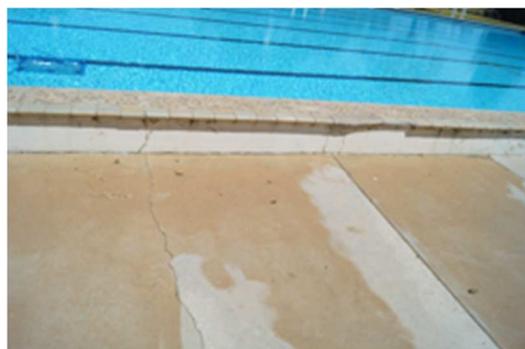
Safety signs and depth markers consist of painted signs on the concourse which are faded. There are also depth markers located above the line of the scum gutter. The signs are no longer legible due to continual maintenance and repairs to the concourse.

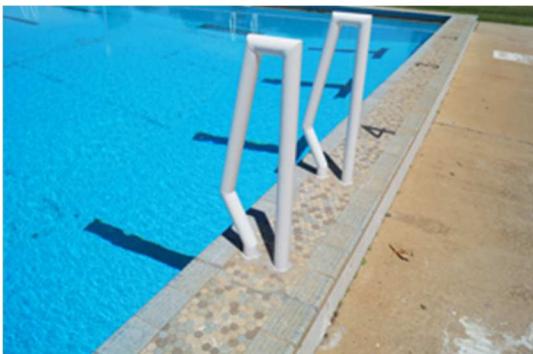
View showing the cracking along the junction of the upstand at the base and also beneath the tiles. Cracks are across the tiles and vertical.

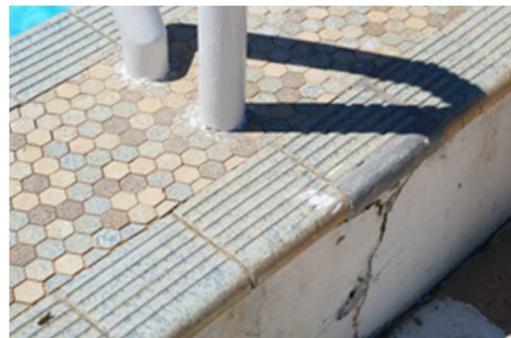
The cracking to the upstand. Cracks runs horizontal along the top and vertical to meet cracking long the concourse paving.

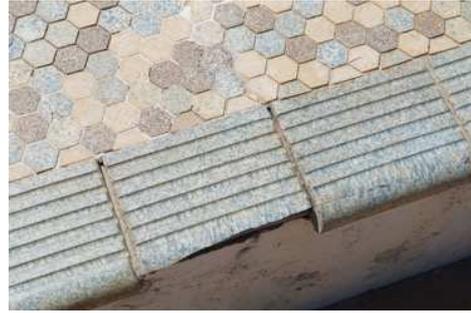
The bullnose tiles cracks which split off.

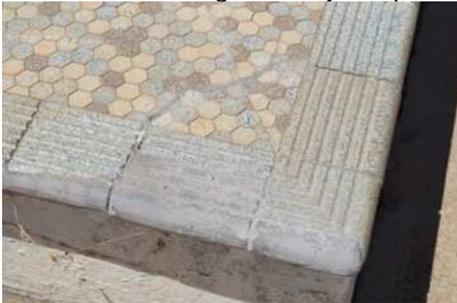
Example of regular repairs to the bullnose tiles using concrete to form the original shape.

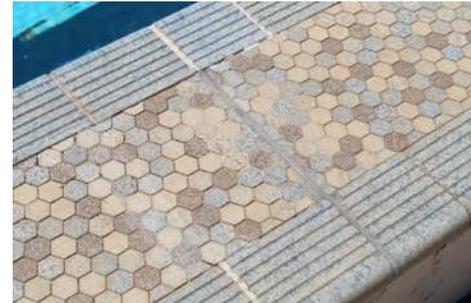
Continuous crack repairs where the tiles have substantially moved apart.

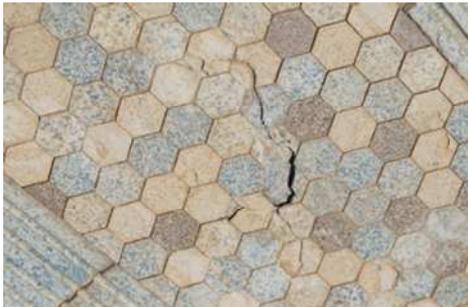
The hexagonal tiles are made of two different thicknesses, where there has been collapse of the substrata due to erosion by water there is irregular cracking through the hexagonal tiles as the thinner tiles settle unevenly. The mortar joints around the tiles are regularly repaired but by summers end are eroded again.

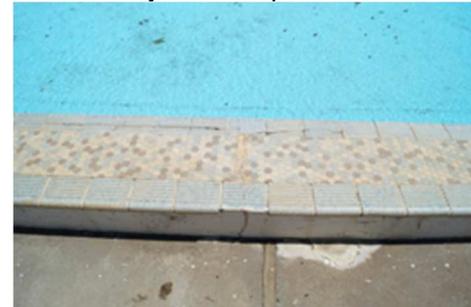
There is evidence of both horizontal cracking and vertical cracking to over 75% of the tiling. This corresponds to widespread horizontal and vertical cracking to the upstand kerb around the pool where the reinforced bars have deteriorated, causing damage.

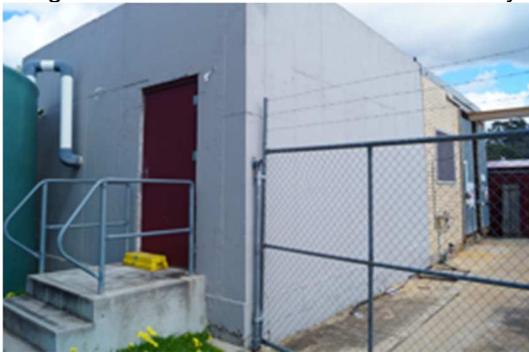
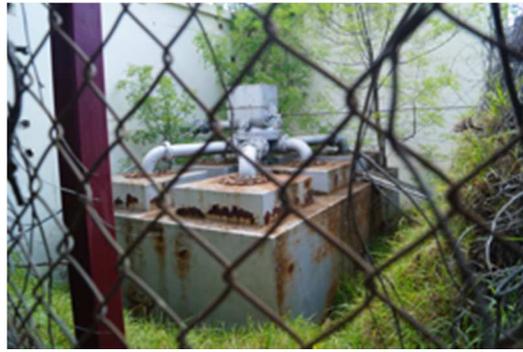
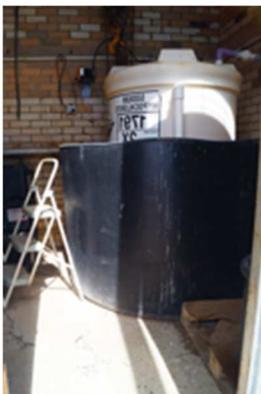
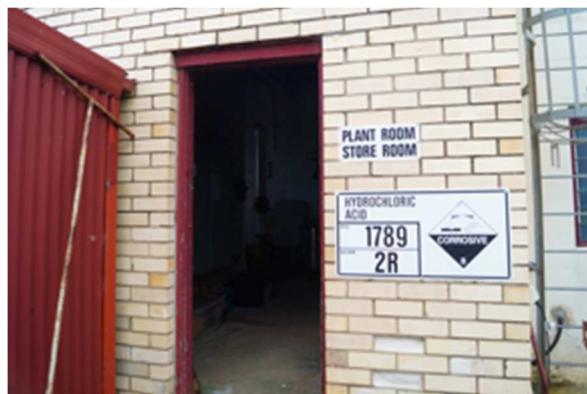
There is also a redundant chlorine storage room with a badly spalled concrete floor. The chlorine storage room consists of a small veranda style enclosure with 'shade cloth' walls.

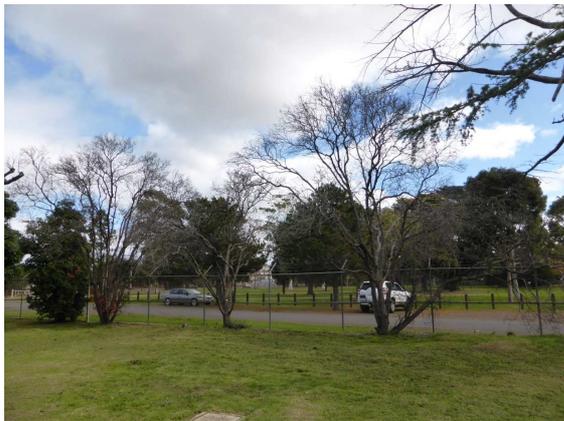
A Photinia serratifolia hedge x4, 3 dead plants and 2 stumps  
Coppice living plant to 0.5m and replant 6 new Photinia. Mulch all plants

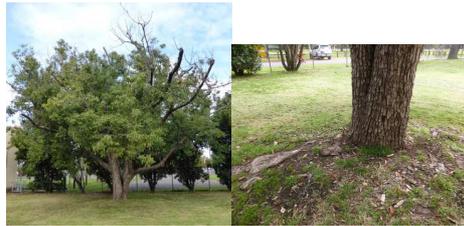
C Cinnamomum camphora has extensive deadwood and root damage  
 Prune deadwood and shape crown, formative prune to improve branch structure  
 Top dress exposed roots  
 Mulch raised root zone for a distance of 3-4m radius,
