Draft Report

Vegetation Management Report, Tullaroop Creek, Carisbrook

13 August 2021

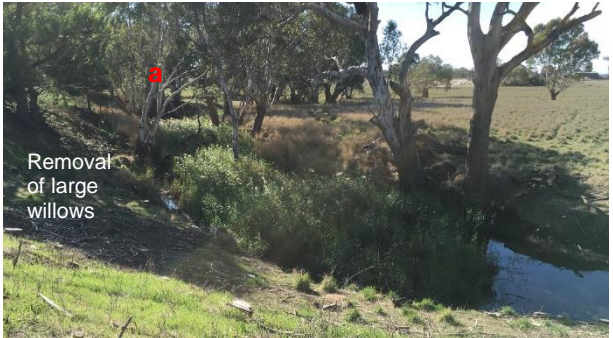
<p data-bbox="831 465 922 539">Removal of large willows</p> <p data-bbox="954 383 970 405">a</p>

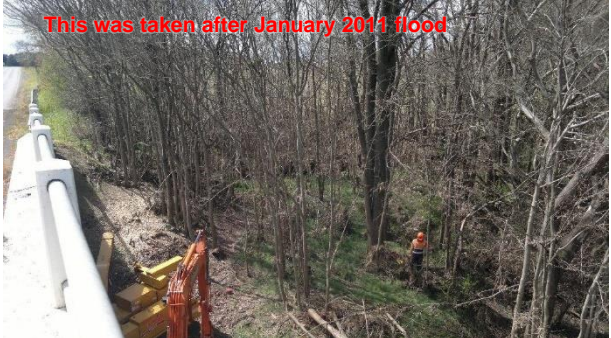
<p data-bbox="204 689 619 719">This was taken after January 2011 flood</p> <p data-bbox="587 1238 603 1261">a</p>

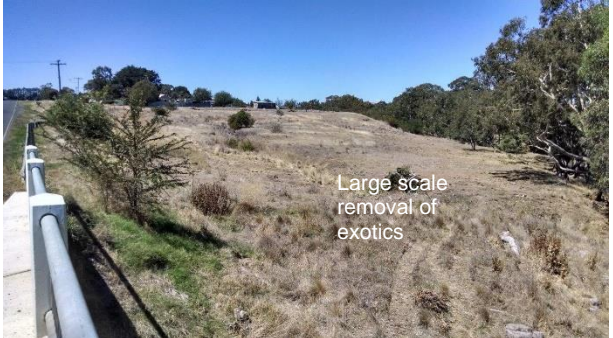
<p data-bbox="1145 846 1257 920">Large scale removal of exotics</p> <p data-bbox="954 1238 970 1261">a</p>

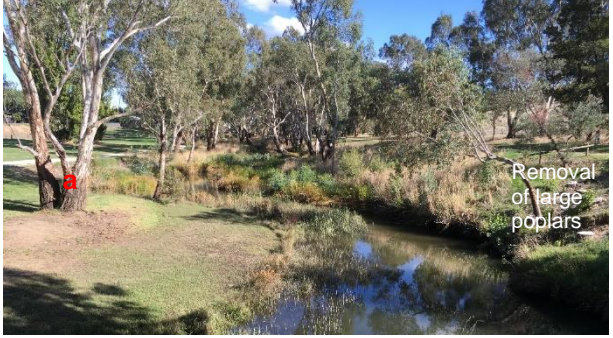
<p data-bbox="1321 1193 1417 1267">Removal of large poplars</p> <p data-bbox="954 1238 970 1261">a</p>

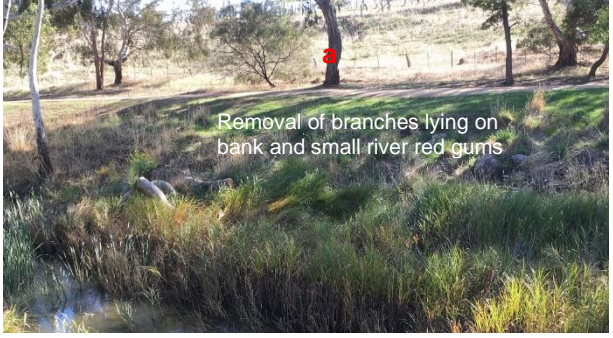
<p data-bbox="1023 1503 1321 1554">Removal of branches lying on bank and small river red gums</p> <p data-bbox="1129 1440 1145 1462">a</p>

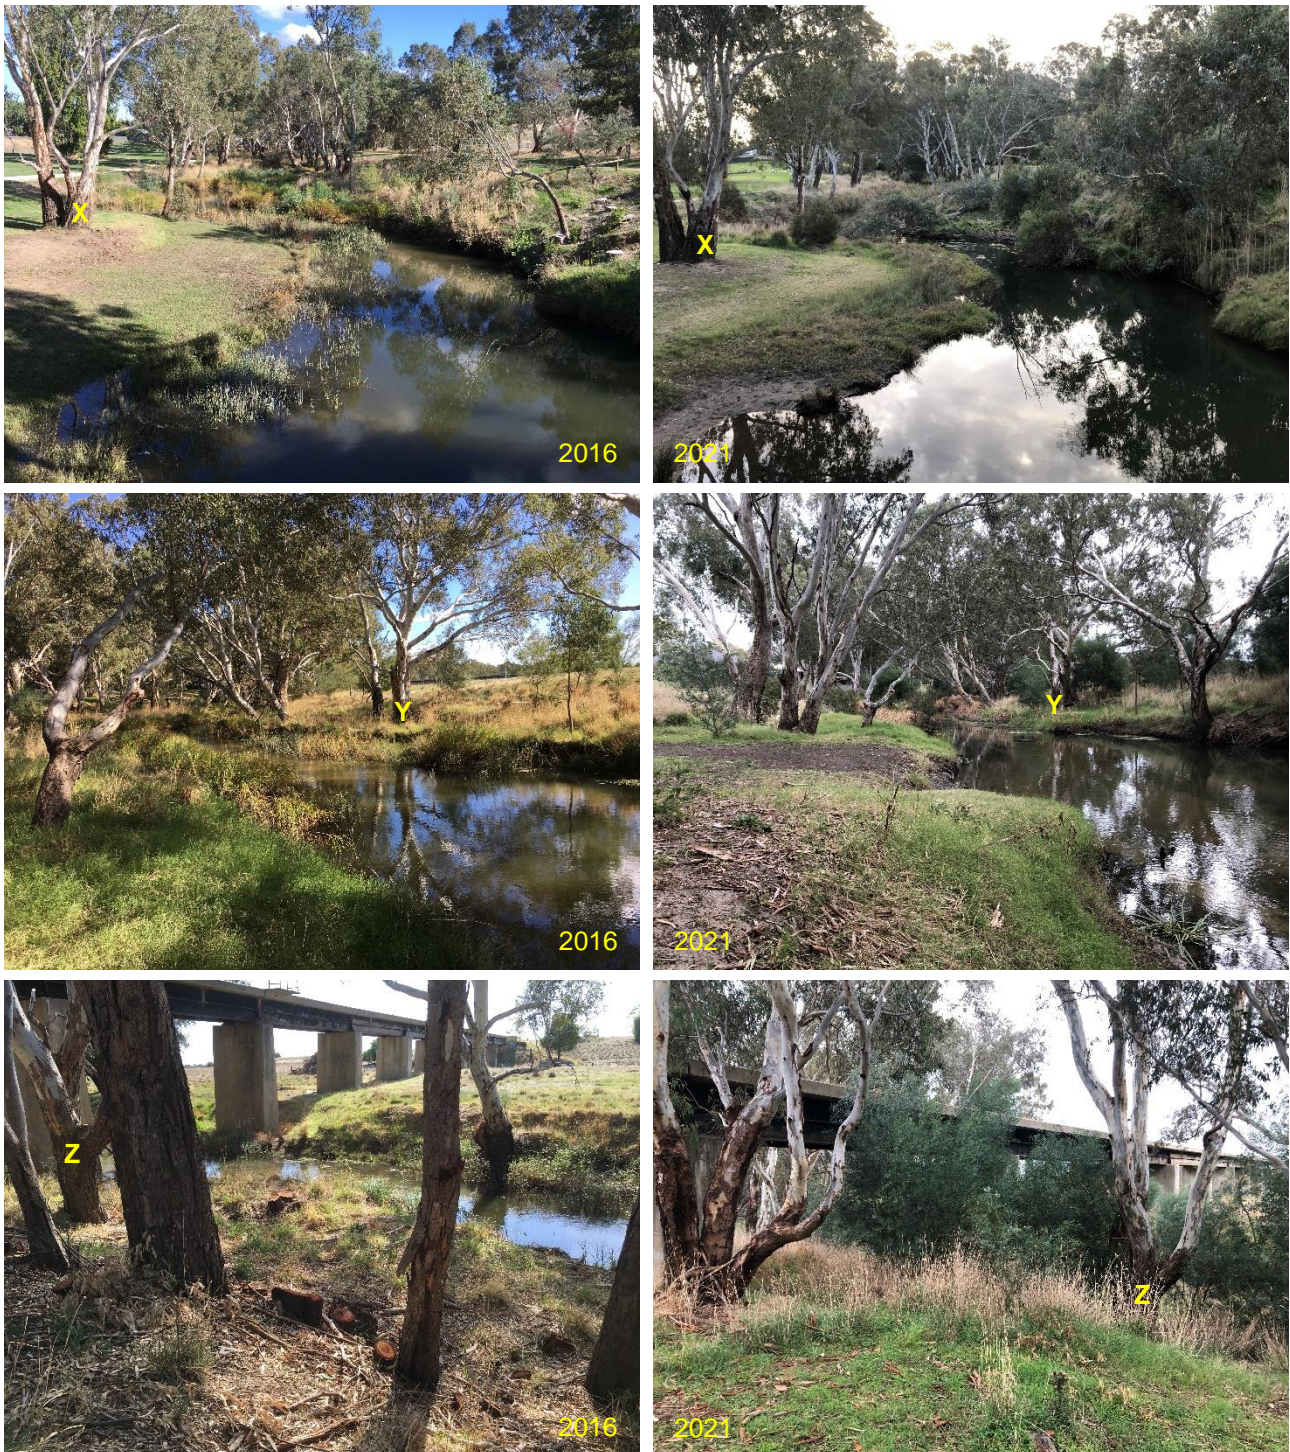
Figure 3-1 Photo comparisons showing increased shrub growth between 2016 and 2021

Following vegetation thinning and clearance post flooding, there was limited understorey remaining, however, there has been regeneration of sub-canopy and understorey species in the subsequent 5 year period. Photo comparisons between 2016 and 2021 at three locations within the project reach are presented in Figure 3-1. These photos show an increase in woody cover, particularly in the understorey shrub layer that is dominated by wattles, mostly Wirilda, (*Acacia provincialis*).

- Manage wattle to current levels of cover. It is recommended to periodically thin wattles to ensure a mixed age of plants persist throughout the project reach, while limiting the expansion of current (Winter 2021) cover.

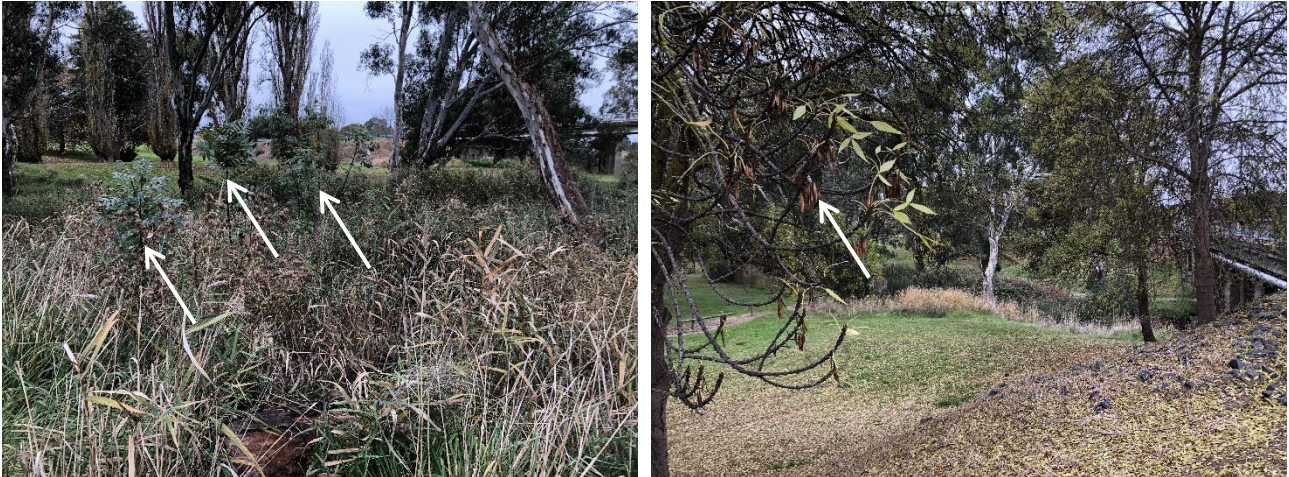
Figure 3-2 Desert Ash seedlings and parent plant near highway bridge

Despite the extensive clearing of exotic vegetation post flooding, a few species continue to emerge from seed distribution. Desert Ash (*Fraxinus angustifolia*) were observed throughout the project reach, particularly at the upstream end. Poplar and Blackberry were also observed across the project area.

- Continue the control of all exotic woody species. The current problem species include Desert Ash, Poplar and Blackberry. The removal of seeding parent plants should be undertaken within Crown land and encouraged on adjacent freehold property.
