## **Conservation Management Plan Princes Park Grandstand (VHR1880)**

**40 Park Road, Maryborough 3456  
Allotment 1E,65A Township of Maryborough  
Central Goldfields Shire Council  
NOVEMBER 2021**

Prepared by:  
Amanda Jean, Heritage Architect  
6720 Midland Highway  
Guildford, VIC 3451

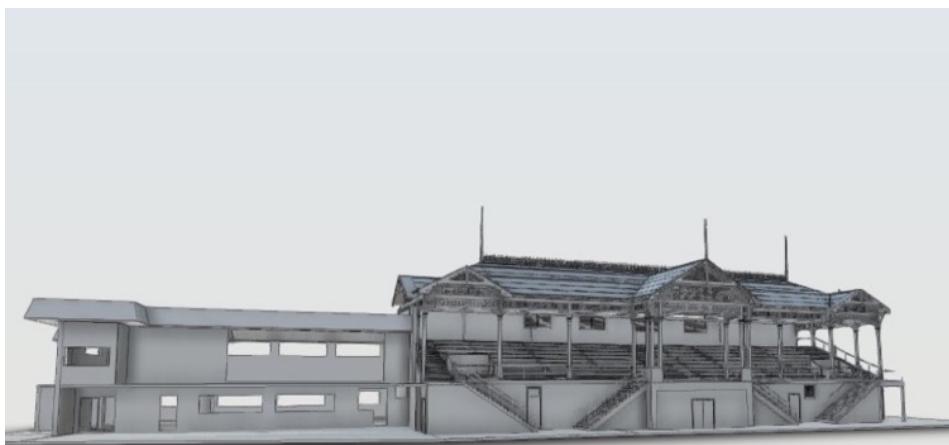
East Elevation Princes Park Grandstand & Clubrooms, (Cardno/TGM, 2021, presented by Mandy Jean).

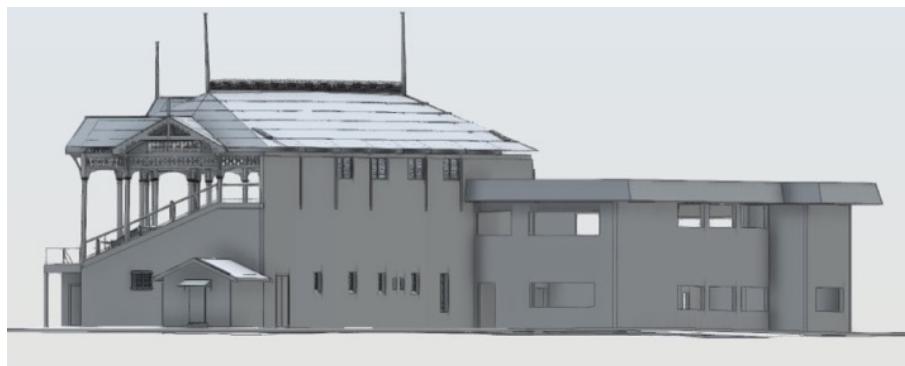
West Elevation Princes Park Grandstand and Clubrooms, (Cardno/TGM, 2021, presented by Mandy Jean).

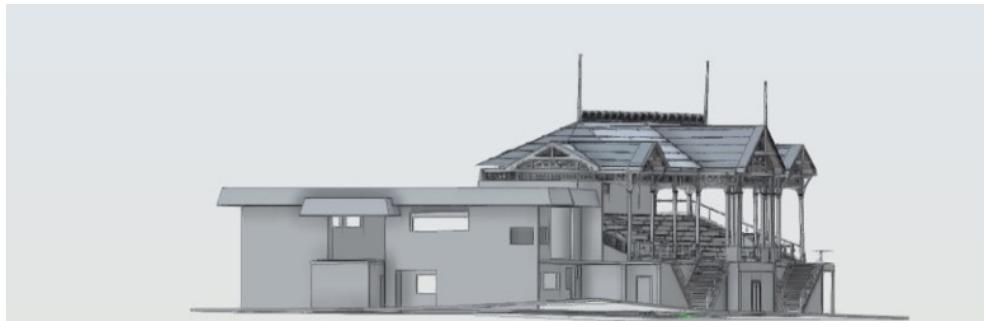
South Elevation Princes Park Grandstand and Clubrooms, (Cardno/TGM, 2021, presented by Mandy Jean).

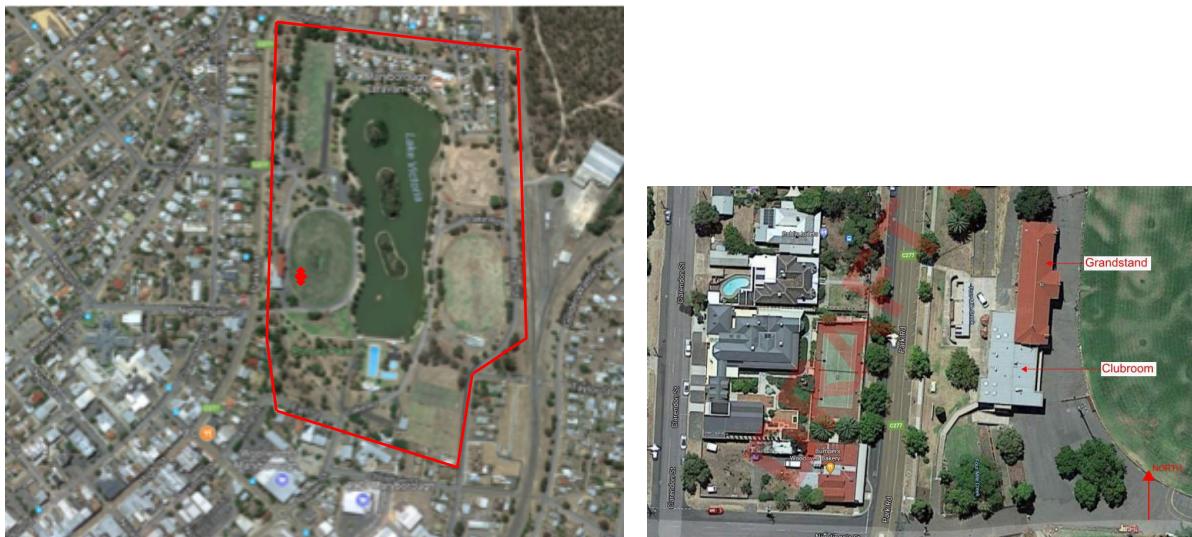
Near Map (CGSC) showing the extent of Princes Park and the location of the Grandstand

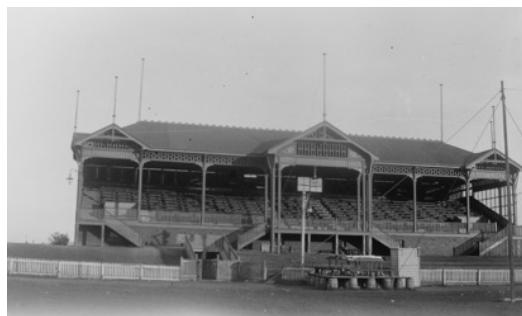
Collingwood Grandstand Victoria Park designed by Thomas Watts Architects, was based on the design of the Princes Park Grandstand, which was also designed by Thomas Watts Architects in 1895. The Victoria Park Grandstand was demolished in 1968.  
Allom Lovell (1996) Conservation Management Plan Victoria Park.

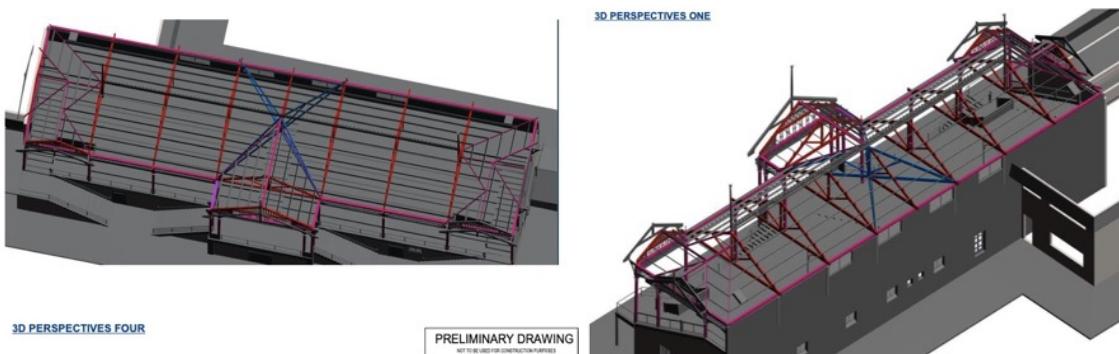
**GENERAL ARRANGEMENT PLAN - ROOF**

**ROOF STRUCTURE:** survey and dimension drawings, photographs and structural analysis by CARDNO/TGM Dilapidation Report, James Lversage, Cardno/TGM and 3-D Scan Chris White/Nathan Farrell, Cardno/TGM 17/07/2021

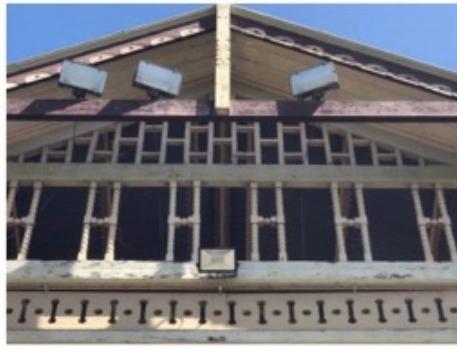
Photo G-FR14

**ROOF STRUCTURE/GABLE:** survey and dimension drawings, photographs and structural analysis by CARDNO/TGM, Dilapidation Report, James Lversage, Cardno/TGM and 3-D Scan Chris White/Nathan Farrell, Cardno/TGM, 17/07/2021.

The roof structure is made up of a series of timber trusses, timber hip & valley beams with timber purlins supporting metal roof sheeting. The trusses are supported on timber pitching beam over timber posts on the east and west side. Infill masonry has been constructed on the west side. A series of steel rod cross bracing is located for the length of the roof structure at truss bottom chord level.

- The struts are connected to king post and top chords (or principle rafters) with mortice & tenon joints.
- The bottom chord (or tie beam) is connected to the king post with steel stirrup strap with what appears to be a gib & cotter. We assume the king post is also connected to the tie beam with a mortice & tenon joint.
- Top chords (or principle rafters) are connected to King post with a two-way steel strap only suggesting these also have a mortice & tenon joints.
- Top chord (or principle rafter) is connected to the bottom chord (or tie beam) with a mortice & tenon joint and tie rod.

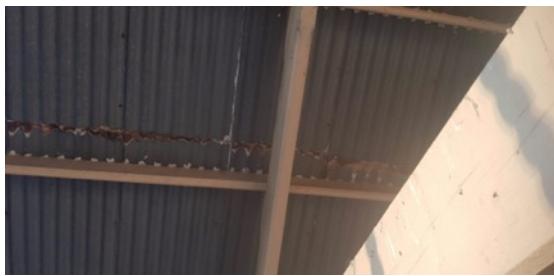
Corrugated galvanized roof sheeting

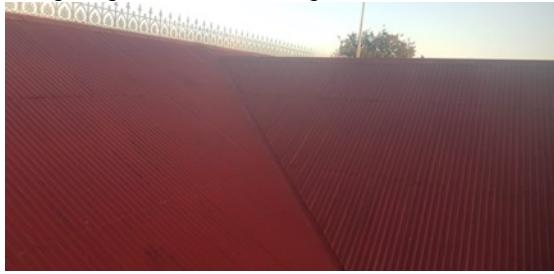
Corrugated galvanized roof sheeting

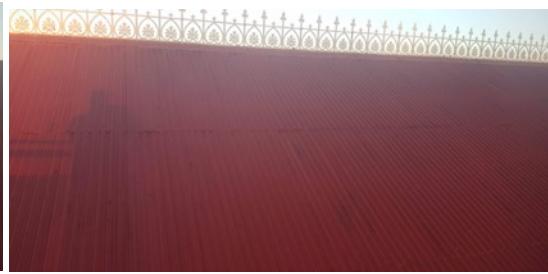
Structural timber, series of roof trusses support the main hip and five gables.

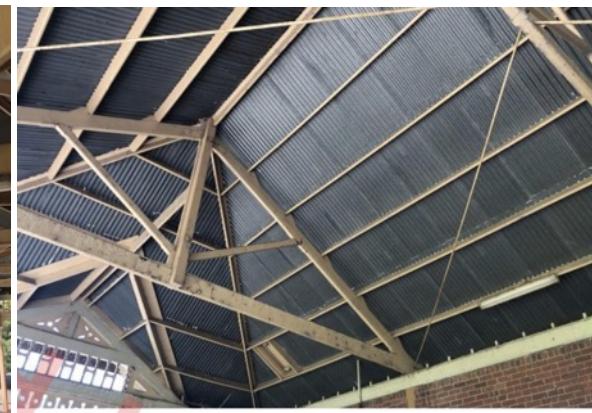
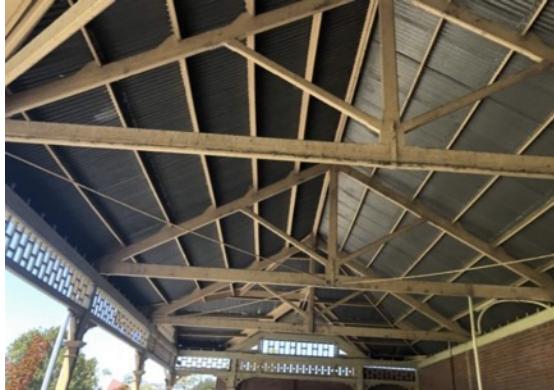
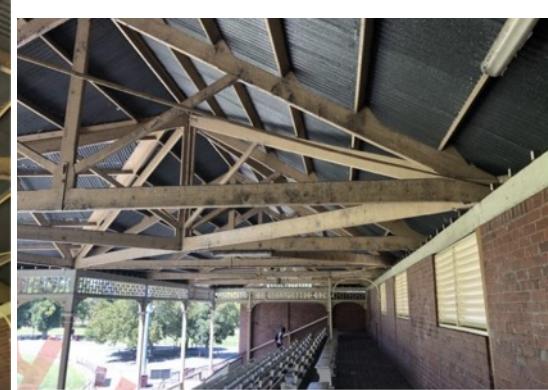
Photographs from CARDNO/TGM 2021.

The tiered seating is generally made up of 19mm boards over 150 x 50 HW timber joists in turn supported by 320 x 100 HW bearers. These bearers are then supported on a trussed sub-floor system as shown below. These trusses are spaced at approximately 5.0m centres. The primary sub-floor truss system is then supported on masonry piers each end as well as by intermediate timber posts.

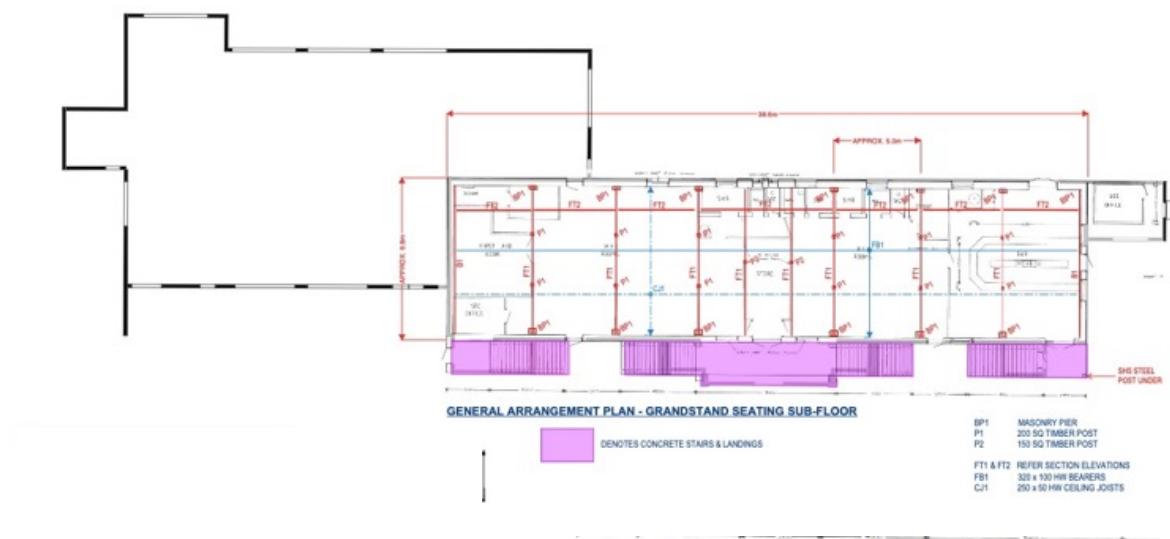
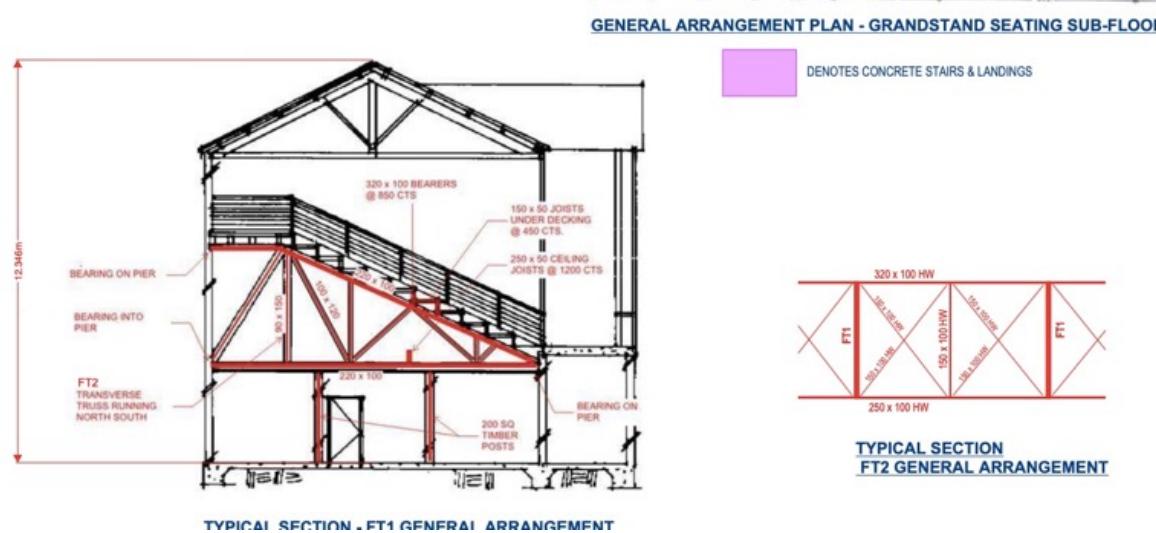
Interior view of the raked seating structure.

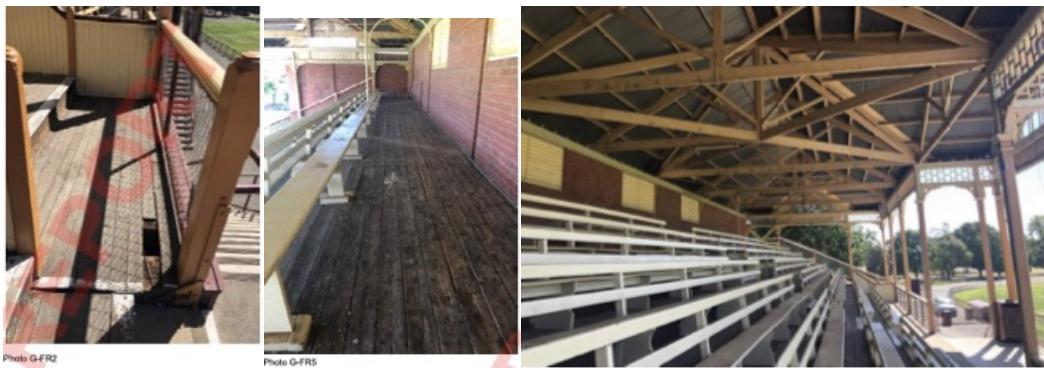
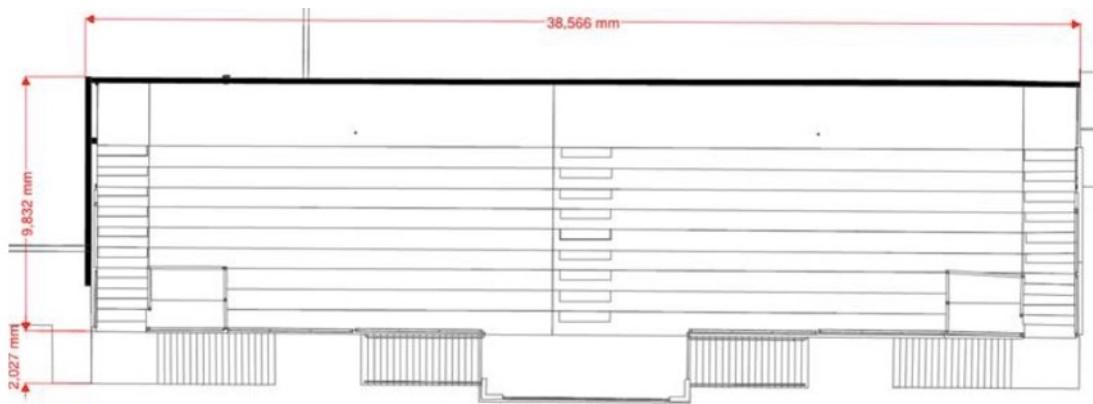
Plan of raked seating area in the Maryborough Grandstand with a size of 38,566mm by 9832mm with external brick and concrete stairways of 2,027mm width.

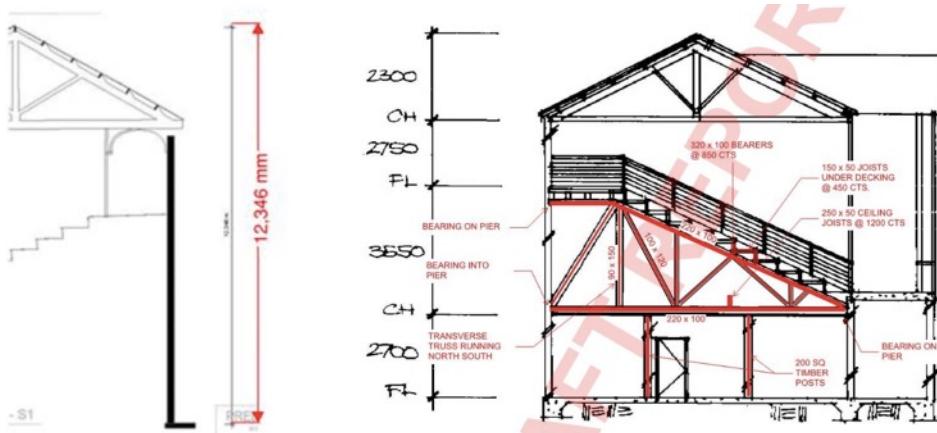
**Roof design as shown above is known as a King post truss with struts system.**

There is 12 dia rod bracing installed end to end at tie beam level. I don't believe there has been any replacement members however the first trusses in from each end look to have had the king post stiffened / strengthened with an additional post bolted through the original king post.

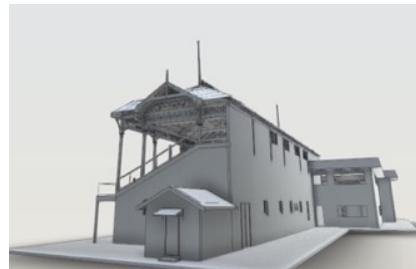
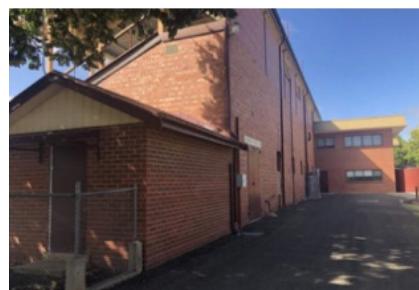
The external access stairs to the grandstand are not part of the original build and have been constructed of concrete supported on masonry walls.

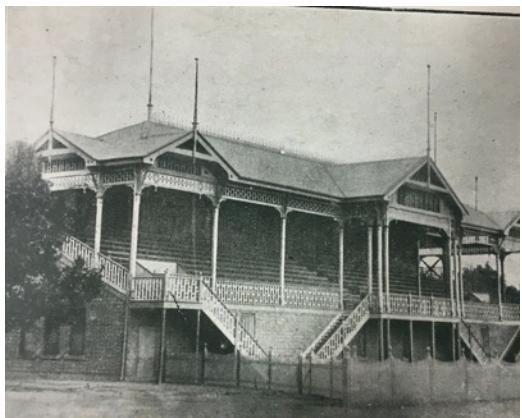
The Grandstand 1903 with original timber external stairways and decorative balustrading.

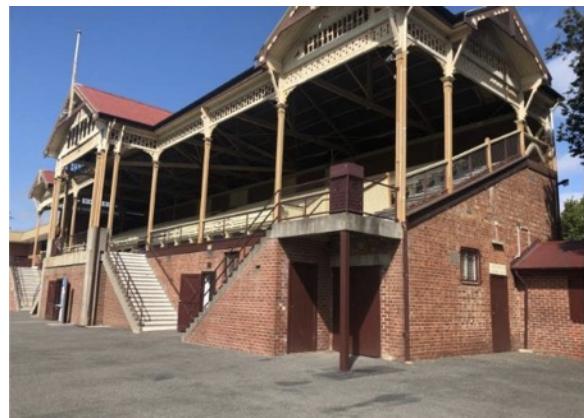
The original timber external stairways were rebuilt circa 1977, when the adjacent Club Rooms were constructed. At this time the lower section of the timber posts were removed and replaced with solid masonry brick walls. All decorative timber balustrading was removed between 1970s to early 2000s.

The Grandstand in 2021, replaced enclosed brick stairs and replaced original balustrade and altered fenestration at ground level.

6. Remedial works to repair all cracks on the circa 1950-1970s brick and concrete external stairs to the east elevation of the Grandstand. This work is not structural at this stage. Remedial work to all external brick walls, repair missing mortar and cracks in all brick masonry work.

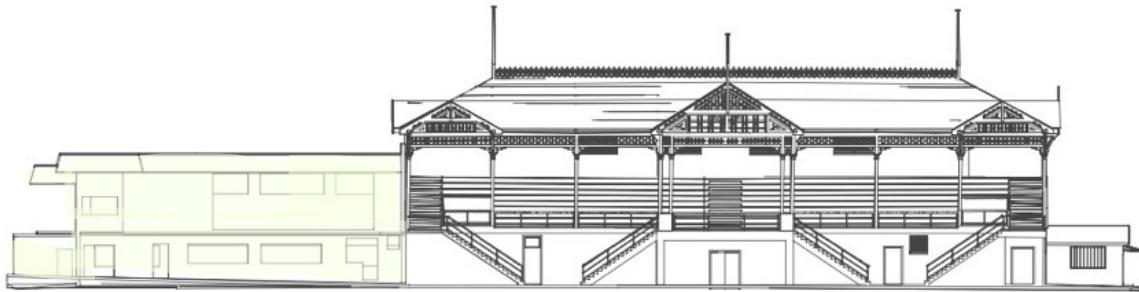
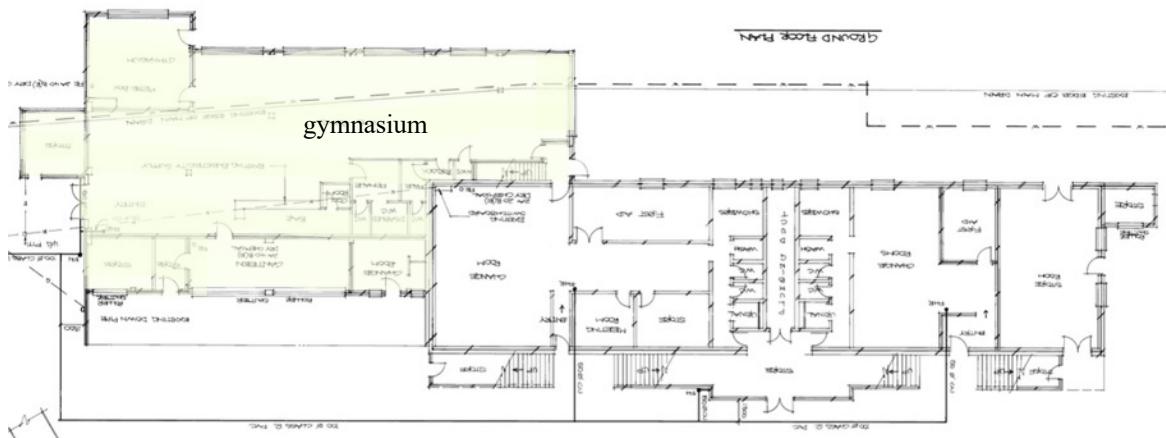
In 1977 plans were prepared to upgrade the existing lower ground level clubrooms shown on the left and construct an addition to the Grandstand as shown above. The new Club Rooms extended to the rear of the grandstand where access was created to a large gymnasium and also stairs to access the upper level of the new building.

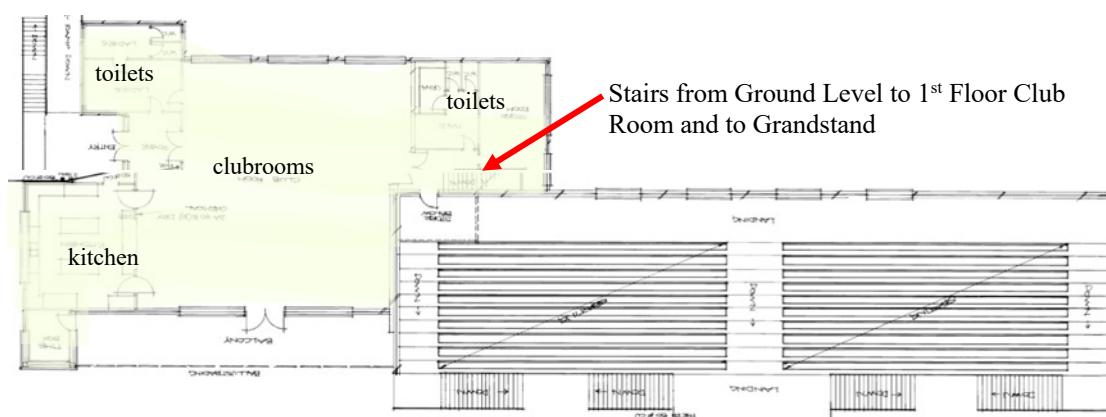
First Level 1977 Club Room and 1892 Grandstand Raked Seating Area

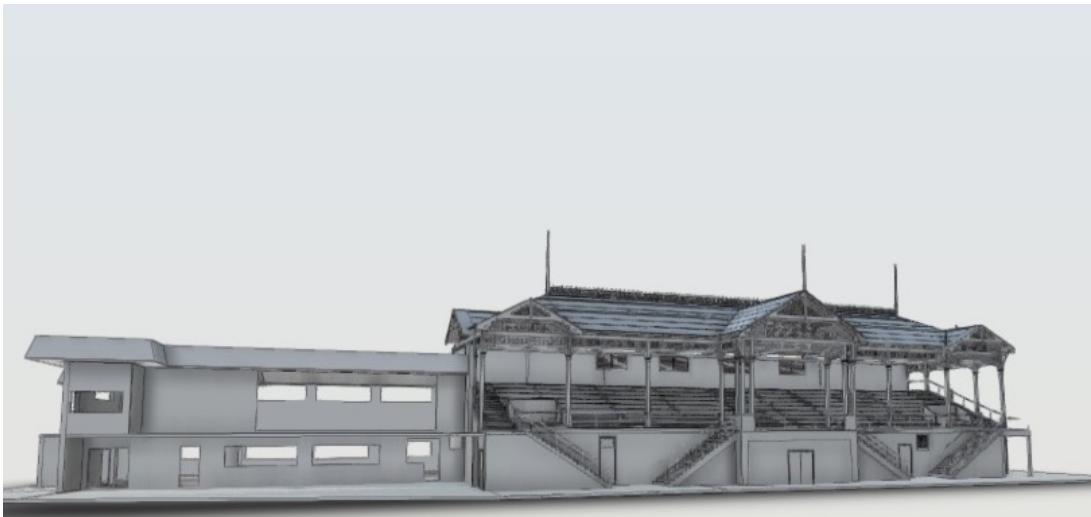
Scan image of the 1977 Club Rooms and the 1895 Grandstand

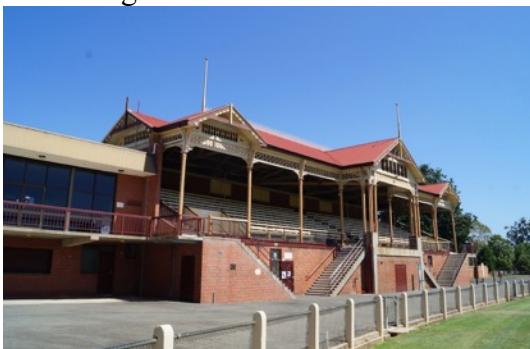
View of the 1977 new Club Rooms.

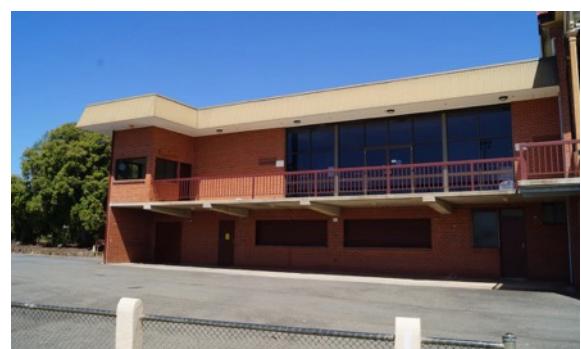
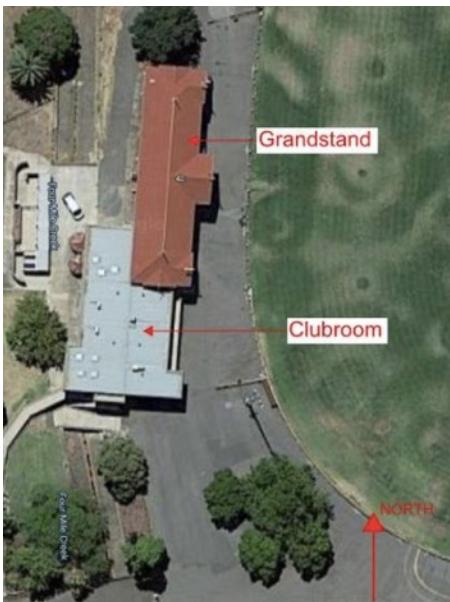
### CLUB ROOMS 1977:

Survey and dimensions drawings, photographs and structural assessment, Cardno/TGM and 3-D Scan Chris White/National Trust

The Club Room was designed by engineers, Kinnaird Hill deRohan and Young Pty Ltd, in 1977. The building is predominantly a concrete framed building. The first floor is constructed of conventionally reinforced concrete slabs spanning between concrete 'T' beams supported by concrete columns. Foundations are constructed of reinforced concrete. The roof structure consists of steel purlins supported by a series of steel trussed rafters in turn supported by steel columns. The perimeter wall construction is full (i.e. double skinned) masonry.

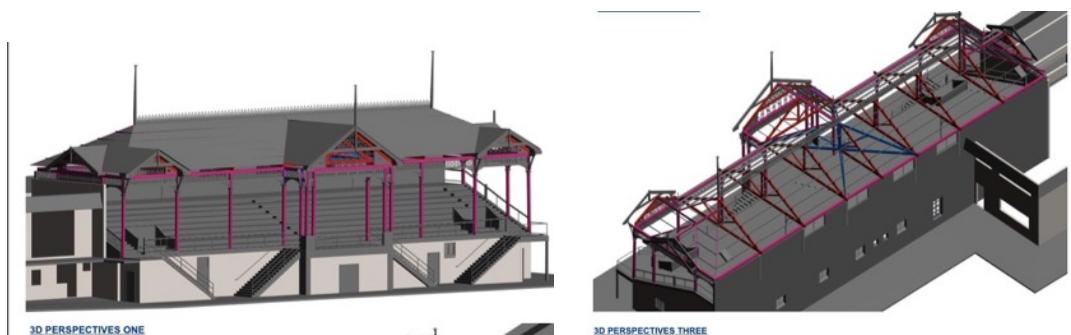
Location /Ref	Galvanized Corrugated Roof and Roof Plumbing	Repair Type	Size	Comments	Priority
Roof Cladding and roof plumbing	<p>The roof covering is made up of a series of short lengths of corrugated sheeting, metal ridge and hip capping, and short valley gutters. The main roof is hipped with a central large gable end and two smaller gable ends on each front elevation corners. There is a decorative metal filigree along the main ridge capping and tall timber finials on each hip and gable end. Roof plumbing consists of simple quad gutters and round galvanised downpipes that connect into a stormwater system around the building.</p> <p>The corrugated metal sheeting appears original c. 1895. Reuse of original corrugated iron sheets is preferred over replacement. The aim is to stop corrosion, while the metal is impermeable, condensation that is trapped between the layers of metal sheets leads to coating failure. Water running over rusted surfaces will cause staining on walls and timber below.</p>	<p>Corrugated galvanized metal roof lining sheets to be replaced where they are deteriorated, lifted, damaged, rusted and replaced with like for like.</p> <p>Roof plumbing to be replaced where necessary. Some sections have recently been replaced.</p> <p>Ensure compatible metals and compliant sizes and profiles, galvanized metal products.</p> <p>Ensure all rainwater down pipes are adequately fixed to the building and connected to the stormwater drainage system.</p>	All	<p>The corrugated sheeting is damaged, rusted, at the edges and around nail fixings.</p> <p>Rainwater is entering beneath, dripping onto the timber rafters and flowing down to the nearest</p>	High/1

1. Replacement of the corrugated metal sheet roofing and associated roof plumbing.
2. Replacement of the timber tongue and groove lining boards to the entire floor area and steps of the raked seating area. Included in this work should be a structural inspection of the sub-floor area and following structural engineer's instructions, strengthening of the timber structure, tightening of fastenings in compliance with building codes.

Repairs to corrugated iron roofing should be with galvanised corrugated iron to the original profile and thickness and using fixings to match the original. If possible, sheets in good condition should be retained and new rolled corrugated sheets to match existing profile, thickness and lengths. There are local manufacturers, use of 9mm thick galvanized sheeting.

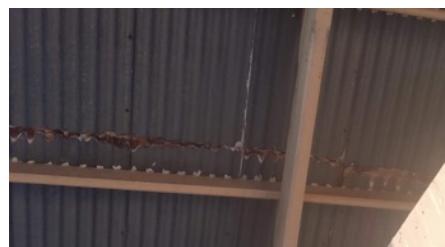
View showing damage and deterioration to the galvanized roof sheeting particularly at the overlapping areas. Due in part to coating failure and corrosion of the metal, including entrapment of moisture between the layers of sheets. This in turn will reduce the structural strength of the sheets.

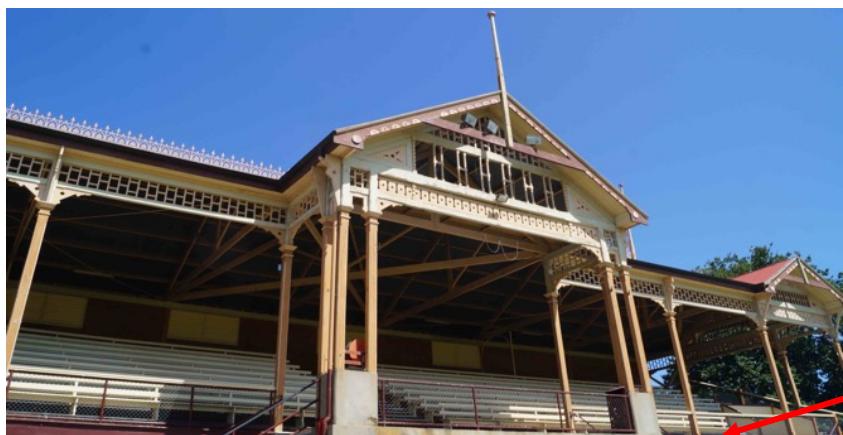
Rainwater is entering through the rusted lap joints and rusted nail/screw holes of the corrugated roof sheeting onto the rafters below. This combined with age and general structural creep, deflection and sagging of the timber members, slight movement especially towards the north east corner is causing gradual loosening of all joints.

It is recommended that all missing decorative timber detailing is reinstated. Loose timber decorative details have been removed and stored at the Council depot for safe keeping and safety. I:I scale dimensioned sketches should be prepared for reconstruction and replacement exactly like for like. This includes replacing the balustrade.

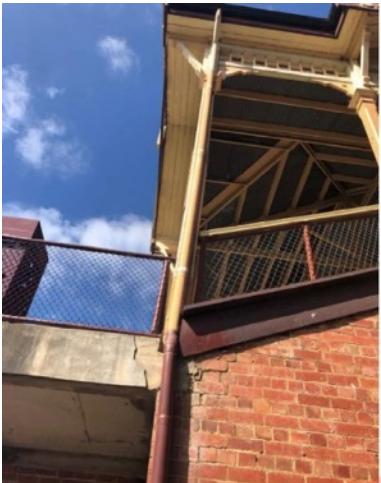
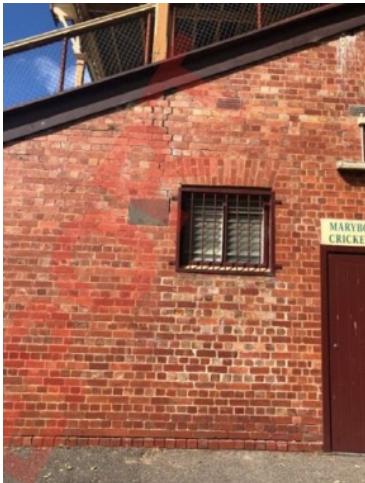
View of the northeast - corner where the timber post is leaning to the west. There is a visible lean to the west of the north-east corner post. This is the site of previous alterations and settlement. The cause is unknown. Future maintenance is associated with repair of the masonry wall described below.

4. Remedial action to the concrete and timber post on the north-east corner post that is leaning to the west. This needs to be straightened. The post is bearing on the corner of the concrete landing where there has been some movement between the landing interface with the masonry under. This has caused the post to rotate and is now visibly out of vertical alignment. CARDN/TGM recommends that the roof be propped in this zone, while work is undertaken.

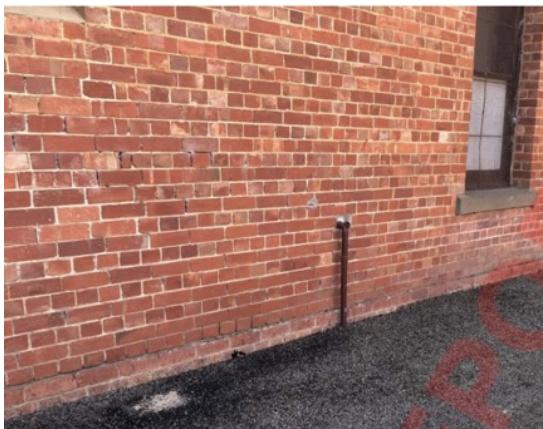
**View of the rear walls mortar joints are loose and eroded.**
