Central Gold-Fields Shire (Former city of Maryborough) Maryborough Heritage Study 1992

BOOK 4 - Park - Wills

FACE BRICK HOUSE, 3-5 PARK ROAD, MARYBOROUGH.

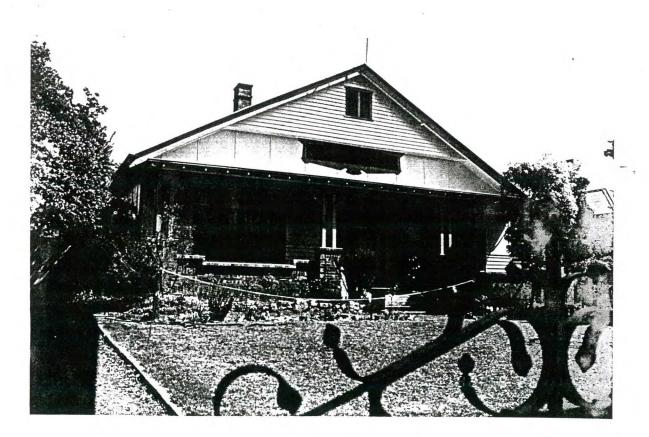
CULTURAL SIGNIFICANCE:

Situated in a row of houses and residences all constructed between the 1890s and the 1900s, number 13 is apparently the oldest of these houses which and been completely rebuilt externally circa 1930. While this house is now very different from its peers, it is architecturally a rare, well-designed and built example of its time, with a history that goes back to the early years of permanent house building here.

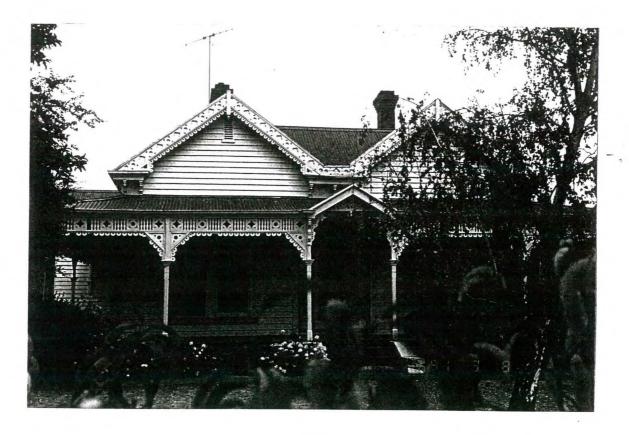
Weatherboard Residence Cont.

CULTURAL SIGNIFICANCE:

Built as the home of Architect William Kell, this residence is a pioneering example in a Victoria-wide context of the use of elaborate timber decoration to replace cast iron, which was almost universally used during the 1880s and preceding decades. By the 1900s the use of decorative timberwork had almost completely supplanted cast iron and it was during the 1890s that the small number of forerunners of this major aesthetic change in Australian building design were first seen, their rarity being due to the major economic depression that began in the early 1890s and lasted for much of that decade. The change to all timber decoration reflected contemporary practice in the United Kingdom and United States and this residence is a good example of both the influence of contemporary overseas funds and the late 19th century general practice of elaborately decorating timber dwellings of any consequence. The traditional lack of economic affluence in the Maryborough community meant there are few dwellings (or other buildings) that are accomplished examples of up-to-date design and/or detailing. Number 31 Inkerman Street is an earlier, larger and more elaborate version of the same basic design and the two buildings share some decorative elements, indicating that most probably the same Architect was involved. This section of Park Road comprises Maryborough's only prestige residential area and architecturally one of Victoria's most important Edwardian residences is next door at number 25.

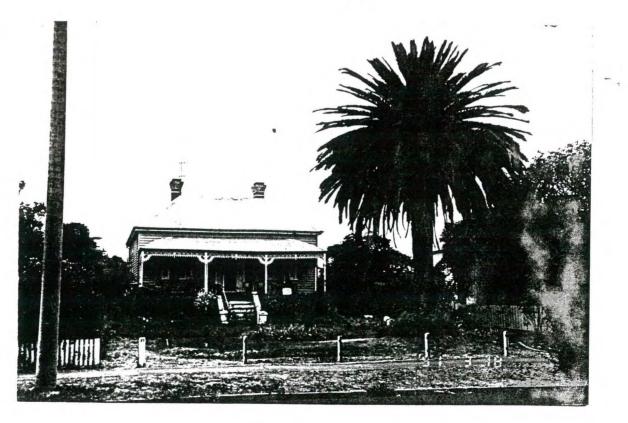
CULTURAL SIGNIFICANCE:

An integral component of the line of dwellings in this section of Park Road that comprise the City's only better-than-average residential area, this building also illustrates the past economic and social prominence of the town's businessmen. Though Maryborough may have been founded as a gold mining settlement in the 1850s and the mining continued up until the 1910s, the local community was never an affluent one (due to a variety of reasons). The better-off in the local community were almost invariably the proprietors of local businesses, rather than gold miners. This building was constructed for a grocer and his competitors lived at numbers 35 (built 1900/1910), 33 (built 1891), 31 (built 1895/1896), 21 (built 1890), 13 (in 1890s) and 9 (built 1892/1893). Following the great economic crash of 1891 there was little building in Victoria until the later years of the 1890s. The few who did build during the first half of the 1890s, as in this case, did so at a much lower cost than before 1891 and were the wealthy or those who survived the economic crash relatively unscathed. The third owner of this house was also a grocer. 5 The palm tree is a relatively rare example of a surviving early private garden tree and a significant element in the streetscape.

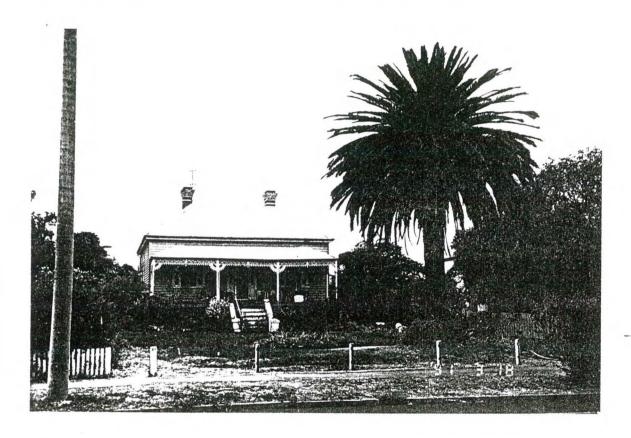
CULTURAL SIGNIFICANCE:

Effective planting in conjunction with 19th century cottage. Tree contributes effectively to the streetscape and provides gardenesque quality.

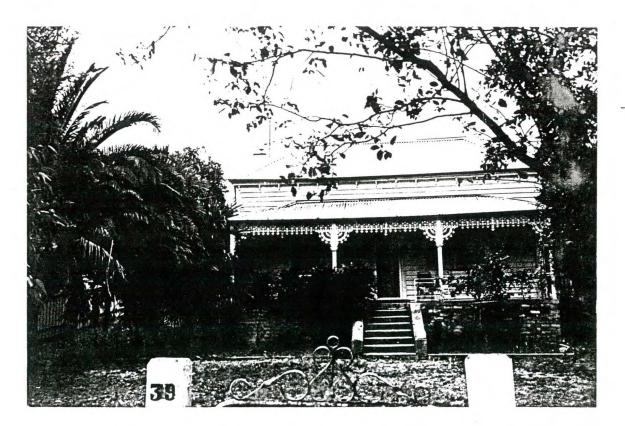
CULTURAL SIGNIFICANCE:

The northern end of the line of dwellings that comprise Maryborough's only better-than-average housing area, this building illustrates the norm for houses constructed in the City prior to 1920. It contrasts with the grander dwellings to be found mostly in the southern end of this line and is of interest as a house built to rent by the publican of the nearby Park Hotel, David W. Curtain. This line of dwellings illustrates the economic and social prominence of Maryborough's businessmen during the 19th and early 20th centuries, the period when the town was solely a gold mining centre. Maryborough has never been a wealthy community and the financially better off have been local businessmen, rather than gold miners. Remains of early or original private gardens are rare in the City and this give these two palms added significance.

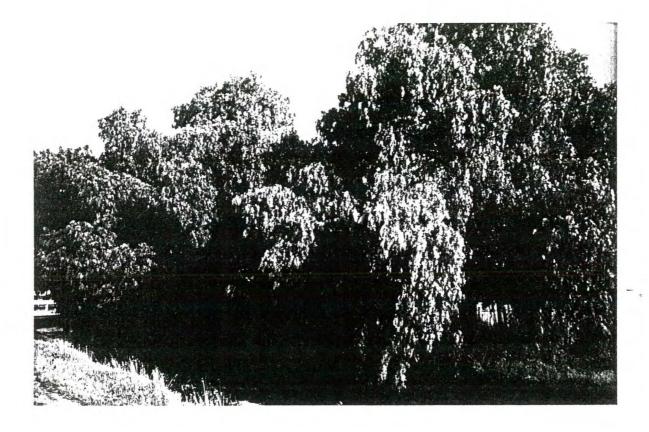
CULTURAL SIGNIFICANCE:

Mature specimens of characteristic landscape elements of rural cities in Victoria. Provide considerable character to streamside area at rear of houses.

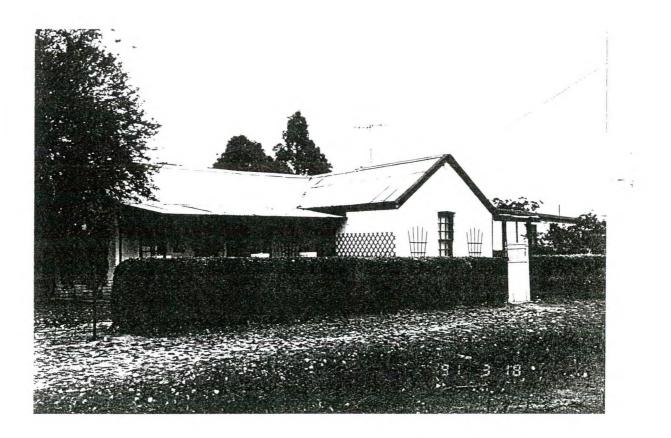
This brick residence has historical significance for its associations with a number of people involved in mining and is one of the City's oldest surviving dwellings. Its simple form exemplifies buildings that were erected in Maryborough from the first discovery of gold here in the 1860s until circa 1890, when the town's by then permanent status allowed the widespread construction of more substantial dwellings to replace this basic sort of building, particularly during the 1900s. Brick dwellings built prior to 1890 are very rare in Maryborough. The first owner, Joseph Rowles, miner and then farmer, located his brick home on the site of an earlier timber home.² John Askwith, miner and then agent, lived there from 1892-99³ and James Dodd, miner, from 1900-1915.⁴ Brick dwellings constructed before 1940 are not common in Maryborough, reflecting the general lack of affluence in the community throughout its history.

Regular maintenance as required. Chemically strip paint from face brick walls. When re-painting use original or period colours.

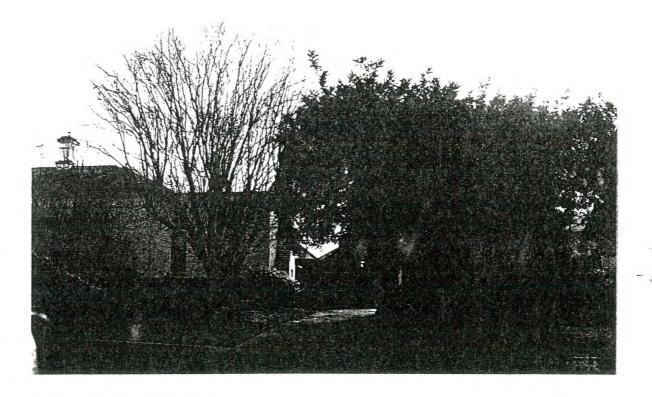
CULTURAL SIGNIFICANCE:

Good specimen of a tree of special suitability in this area, tolerating low rainfall. Planted extensively in the 19th century and this is a multi-trunked mature specimen. Well suited to setting in association with house.

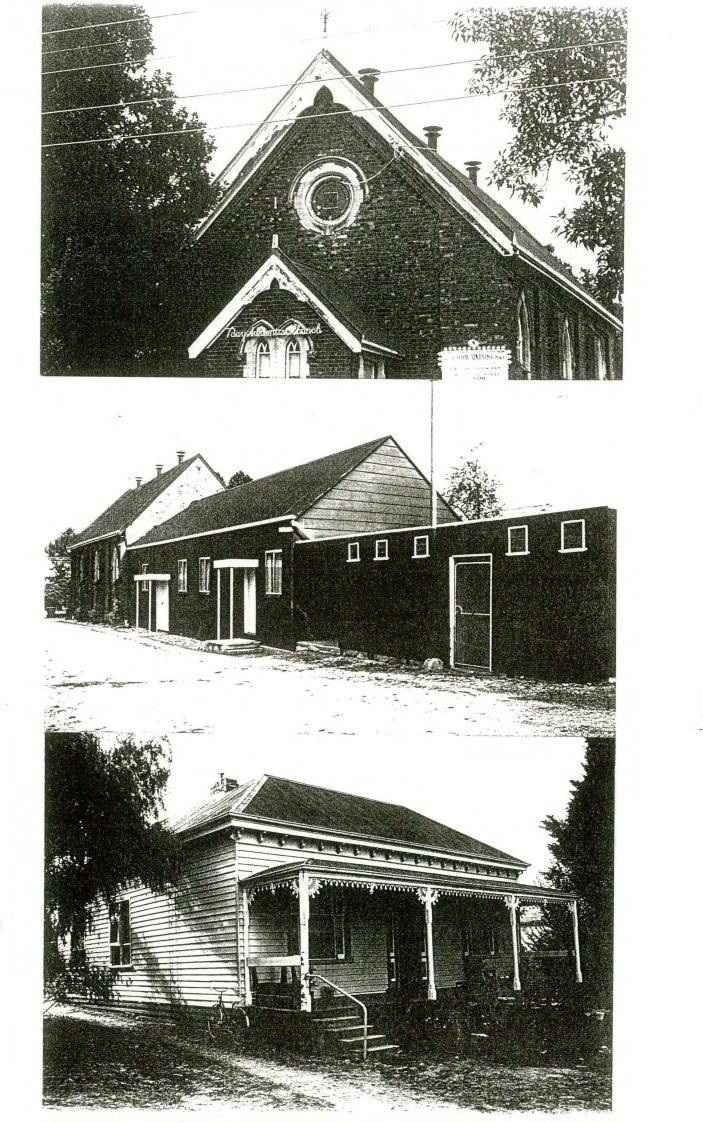
GERALDINE (FORMER DANZIG) - BRICK RESIDENCE, 41-43 RAGLAN STREET, MARYBOROUGH.

The church has a concrete slab floor and this is the cause of the rising damp problem. In the medium/long term this should be replaced with a timber floor.

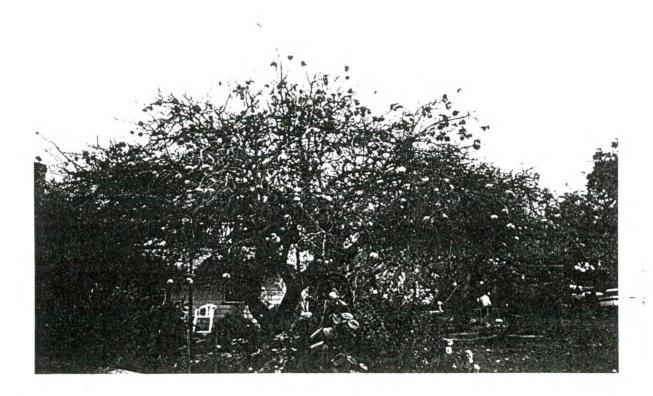
CULTURAL SIGNIFICANCE:

Outstanding specimen of tree, well suited to character of cottage garden and contributes to streetscape and setting.

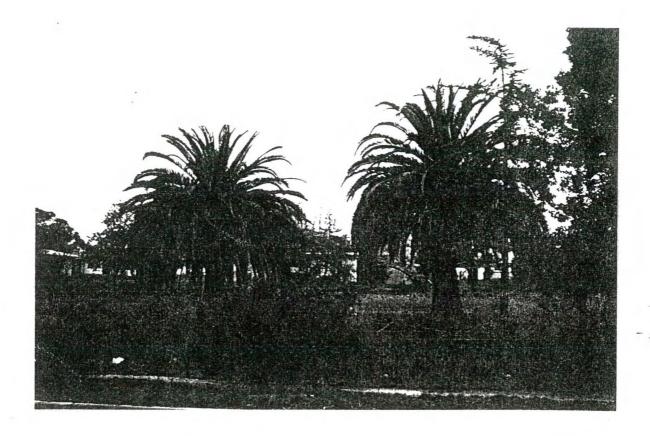
CULTURAL SIGNIFICANCE:

Pair of trees from earlier garden, now somewhat gaunt and isolated on the site. Excellent visual quality in the streetscape.

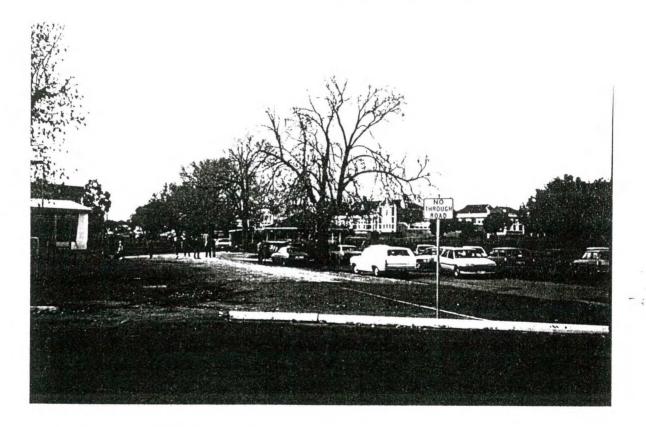
Appear to be in sound condition. There may be a perception that the upper canopy should be lopped but this should be avoided.
