central Goldfields Shire
(Former Shire of Tullaroop)

Heritage Study

**ASSESSMENT OF PLACES OF CULTURAL
SIGNIFICANCE**

**Prepared by Robyn Ballinger and Wendy Jacobs
for Central Goldfields Shire 2002**

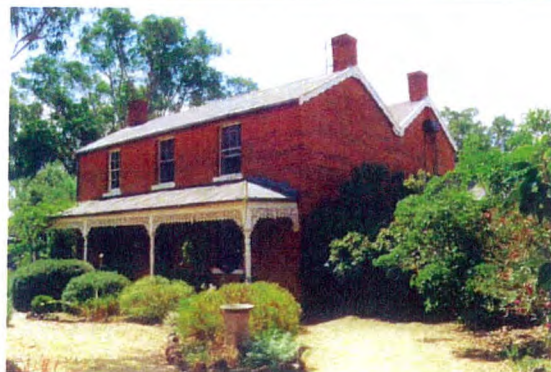
The outbuildings on the property date from the 1930s, and a bridge connecting the two properties was built across the creek in the 1950s. Previous to this, a stone ford was used to traverse the creek.

The house and outbuildings are in good condition externally.

It is recommended that Stonelea, Bung Bong-Wareek Road, Bung Bong be protected under the Heritage Overlay of the Central Goldfields Planning Scheme.

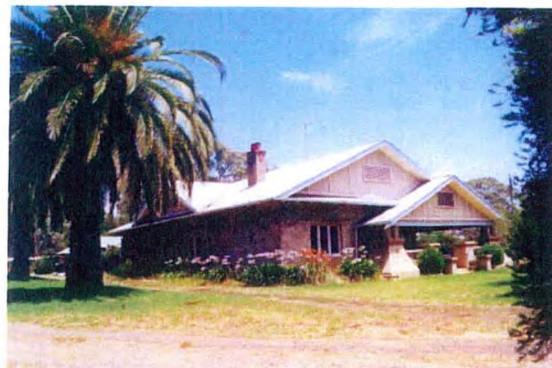
Alvabrae was built next to this building in 1908 by John Steed.

The house appears in good condition externally.

It is recommended that Alvabrae, off Bung Bong-Wareek Road, Bung Bong be protected under the Heritage Overlay of the Central Goldfields Planning Scheme.

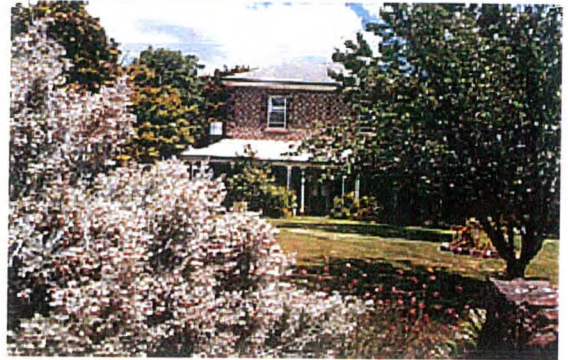
Address	69 Camp Street Carisbrook
Constructed	1862-1874
Building Type	Residential:detached
Architect	Edward Powell
Map Ref.	Carisbrook 954.507

Junction Lodge is in good condition.

It is recommended that the place be retained on the Victorian Heritage Register, the registers of the National Estate, the National Trust and in the Heritage Overlay of the Central Goldfields Planning Scheme.

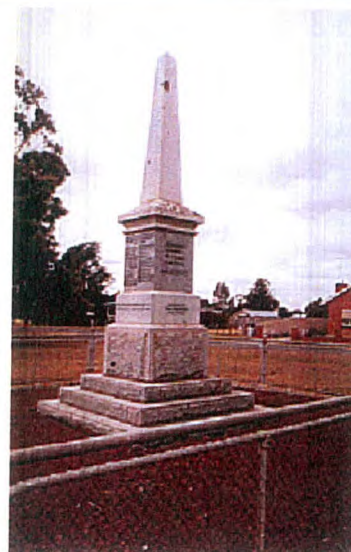
The war memorial is in good condition.

The war memorial is substantially intact.

Recommendations It is recommended that the place be protected under the Heritage Overlay of the Central Goldfields Planning Scheme.

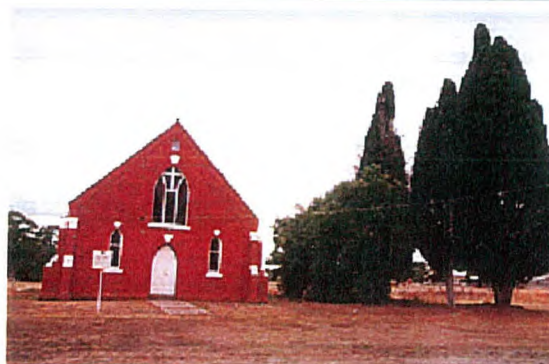
The Uniting Church, Simson Street, Carisbrook is on a flat site and is set back a short distance from the street boundary. The site is grassed and devoid of a front fence. The remains of what appears to have been a hedge or windbreak of cypress trees are on the right hand side. The buildings comprise the brick church with the brick church hall to the left of the main church. The church is a rectangular plan nave with a small rectangular sanctuary attached to the back of the nave. Both sections have steep gable roofs. The church is of face red brick on a shallow stone plinth with render cappings to the buttresses, render sills and fan shaped render keystones above the Gothic arched windows. The rake of the gable end is marked by a band of stepped brickwork which continues vertically as an extension of the corner buttresses. The church has a central Gothic arched doorway facing the street flanked on each side by a narrow arched window. Above the door in the centre of the gable end is a wide Gothic arched window divided into Peter and Paul arched panes with a central cross motif. Each of the openings is marked by brick voussoirs with a central fan shaped rendered keystone. The apex of the gable contains a Gothic arched louvred vent. The entry door is of vertical timber boards and the windows are timber framed. The corners of the building are marked with stepped brick buttresses. The main section of the church is divided into four bays by stepped brick buttresses with a Gothic arched window in the centre of each bay.

Externally the buildings appear to be in good condition.

It is recommended that the Uniting Church and Church Hall Simson Street, Carisbrook be retained on the Heritage Overlay of the Central Goldfields Planning Scheme.

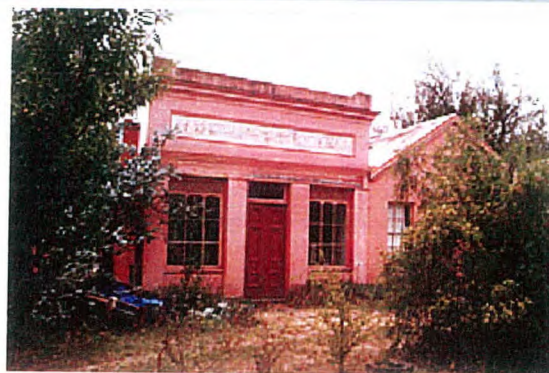
Description The former butcher's shop and attached residence, 6 Bucknall Street, Carisbrook are on a relatively flat site on the street boundary. The buildings are of brick with the shop having a parapet front concealing a gable roof and the house having a gable roof facing the street.

The shop has a straight rendered parapet between two square pedestals on each side. These now lack any decoration. A moulded string course marks the top section of the parapet. The main face of the parapet is smooth rendered with a recessed name panel outlined in moulding across the facade. There are over painted shop signs in this panel. This section is marked by a second string course of moulded plaster and below this is evidence of the attachment of a street verandah which has since been removed. The shop has a central doorway with transom light over and is flanked on each side by matching shop windows. The central doorway retains a pair of narrow panelled doors. The shop windows retain their original window joinery and are divided vertically into three arched headed sections with lattice decoration above. Each arched section is divided into three horizontal panes.

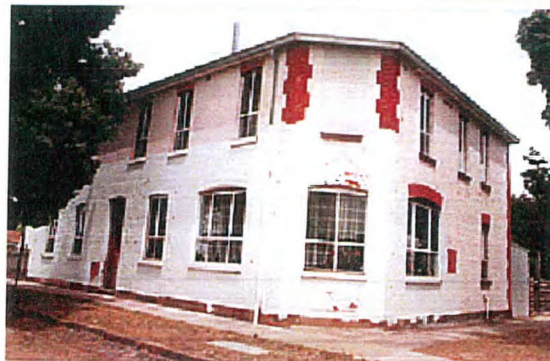
The former Carisbrook Hotel, 7 Bucknall Street, Carisbrook is built on the boundary of the corner site. The building is a two-storey building with a hipped roof. The street intersection corner has been truncated to form an angled wall which would originally have accommodated the bar entry door which is now a window at ground floor level. The building originally was of face brick with flat brick arches above the windows and raised brick quoin work marking the edges of the walls and around the side entry door and window. The brickwork has been painted. The window openings are intact except for the corner upstairs window which has been sheeted over. The corner entry door has been replaced with a window. The windows have been replaced. Some areas of paint have been removed from the brickwork exposing some brick quoin work and window arches.

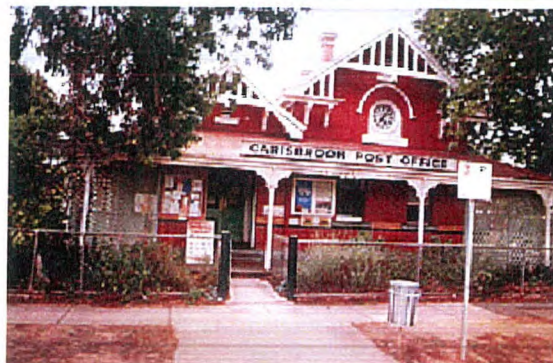
The Carisbrook Post Office, corner Bucknall and Powlett Streets, Carisbrook occupies a flat corner site. The post office entry faces Bucknall Street where there are large exotic street trees. The post office is set back about two metres from the street boundary behind a galvanised pipe and chain mesh fence with square timber gateposts. The single storey building has two parallel main roofs with a transverse hipped section to the rear. The roof is clad in slate. The building retains its tall red brick chimneys with cream brick banding and render capping. The front facade has a two gable ends with timber gable decoration supported on timber brackets. The larger gable projects from the main hip form of the main roof. The brick gable has a central clock with render surrounds and an arched render moulding above. Above the moulding is a rectangular louvred vent opening. The smaller gable has a similar central vent in the gable end. The main walls are of face red brick with cream brick banding at the windowsill level with a black brick band below.

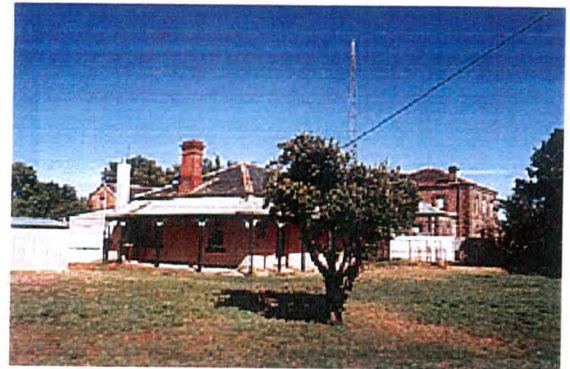
Although re erected on the site in 1881, the police residence is similar to other police residential buildings of the late 1850s and 1860s. The building is a single storey brick building now painted with a single broad hipped slate covered roof. The building retains the characteristic broad brick chimney on one side. The building has a wide corrugated iron return verandah which springs from just under the roof eaves. The verandah has a straight pitched roof and is supported on timber posts with simple arched timber brackets. The

building retains its timber double hung windows. There is a later unsympathetic skillion roof addition to the rear of the building and a number of later sheds on the site.

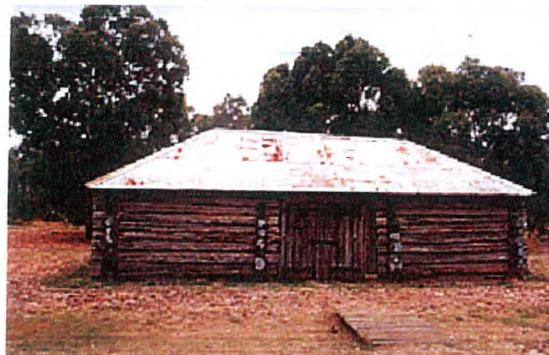
The log lock-up, Bucknall Street, Carisbrook, has been variously altered, but is in good condition relative to its age and is essentially intact.

Integrity	The integrity is medium.
Recommendations	It is recommended that the place be retained on the Registers of the National Estate and National Trust and retained on the Heritage Overlay of the Central Goldfields Planning Scheme.
References	Osborn, Betty, Against the Odds: Maryborough 1905-1961, Central Goldfields Shire, Maryborough, 1995, p. 197; Register of the National Estate; Willis, Barbara, Footprints: A History of the Shire of Tullaroop, Shire of Tullaroop, Maryborough, 1988, pp. 106-7;
Assessed by:	WJ, RB June 2001

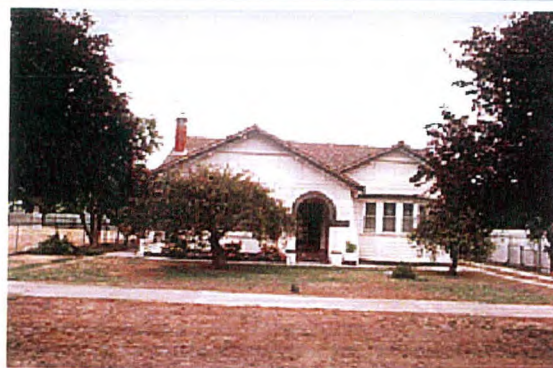
Description 35 Green Street Carisbrook is set back from the street on a flat allotment. The house has no fence and an expanse of front lawn with small trees. The house is a single storeyed 1920s timber bungalow style with large terracotta tiled intersecting roof forms. The house retains one brick chimney with render banding at the top. The house has weatherboard walls with strapped and shingled gable ends. The main feature of the facade is a segmented window bay with flat roof and double hung timber windows. The building retains its stained timber glazed front door. The verandah is under a projecting gable roof, which dominates the front facade and has a brick wall with arched opening with decorative dark glazed voussoirs and horizontal banding.

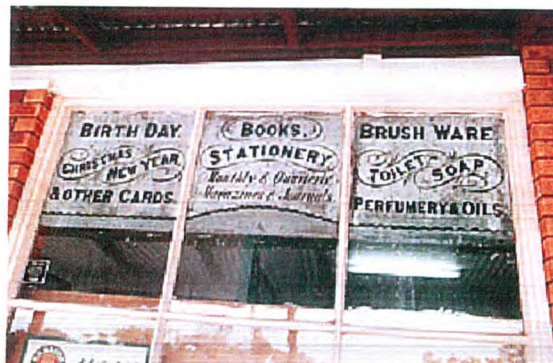
Condition The original sections of the building appear to be in fair to good condition for its age.

Integrity The rear section of the building, roof and left hand shop windows appear substantially intact

Recommendations It is recommended that the newsagency and supermarket, Green Street, Carisbrook be protected under the Heritage Overlay of the Central Goldfields Planning Scheme.

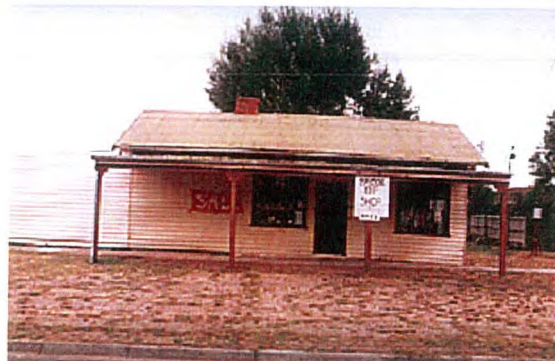
Condition	The building appears to be in good condition externally.	
Integrity	The main section of the shopfront survives with an extension to the left.	
Recommendations	It is recommended that the former Bucknall shop, 15 Green Street, Carisbrook be protected under the Heritage Overlay of the Central Goldfields Planning Scheme.	
References	Daryl McLeish, local historian; Opportunity Shop signage	
Assessed by:	WJ, RB	January 2002

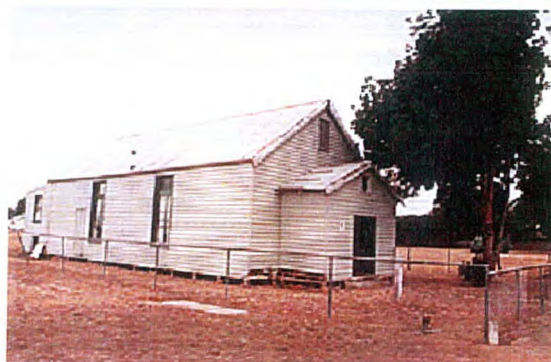
Description The relocated former Joyce's Creek State School Green Street, Carisbrook is sited on a cleared flat site. The building is a standard Early Education Department Single Room School building of the type constructed to house 40 students. Of the 240 schools built during 1873 to 1890 most were timber. They had 12-foot high ceilings and were typically 16 feet wide by 24 feet long. They earlier schools had shingle roofs but after 1877 iron roofs were usual. The timber design style was used unchanged until 1900. The former school is rectangular with a small rectangular porch off set on one gable end. The roof is a gable clad in corrugated steel. There is a skillion roofed later addition on the gable end at the other end of the building from the porch. The porch has the door in the front where it was more usual to have these in the side. This door may be a later alteration. The school has two sets of casement windows with transom lights down one side of the building. The gable has a louvred rectangular vent in its apex. The school building generally had a turned timber finial at the apex of the main roof and the porch roof. These are missing in this example.

Condition The building appears in good to fair condition externally.

Recommendations It is recommended that the former Joyce's Creek School, now scout hall, Green Street, Carisbrook be protected under the Heritage Overlay of the Central Goldfields Planning

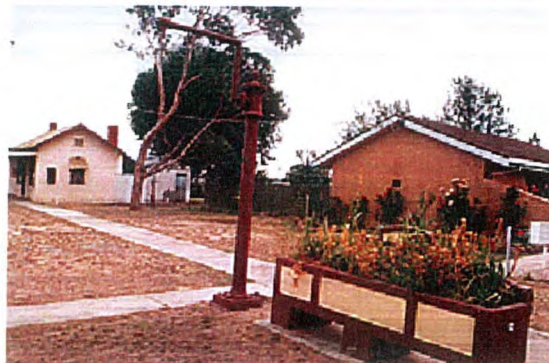
The water cement trough consists of two parts, a large horse and a small dog trough. The larger horse trough has incised rectangular panels on the front of the structure, with an elaborate curved back. The trough rests on rectangular concrete members. The troughs are generally of unpainted concrete. This stand has been painted. The pipe stand consists of a round cast iron column and a horizontal arm with a tap wheel. Adorning the pipe stand is a decorative cast iron finial.

Condition	The pipe stand and trough appear in good condition.	
Integrity	The pipe stand and trough appear in good condition.	
Recommendations	It is recommended that the standpipe and trough, Green Street, Carisbrook be protected under the Heritage Overlay of the Central Goldfields Planning Scheme.	
References	Daryl McLeish, local historian; Mary Bilton, Midlands Historical Society	
Assessed by:	WJ, RB	February 2002

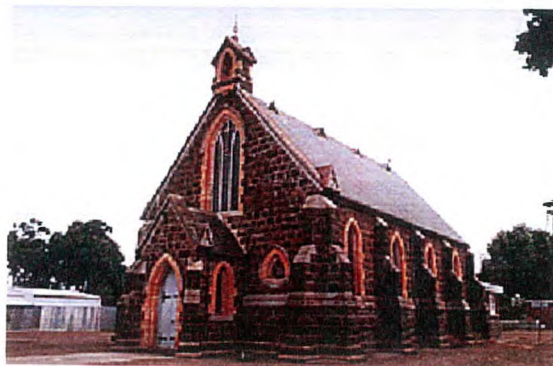
Externally the building appears to be in good condition.

It is recommended that the St Paul's Anglican Church, Urquhart Street, Carisbrook be retained on the Heritage Overlay of the Central Goldfields Planning Scheme and the National Trust Register.

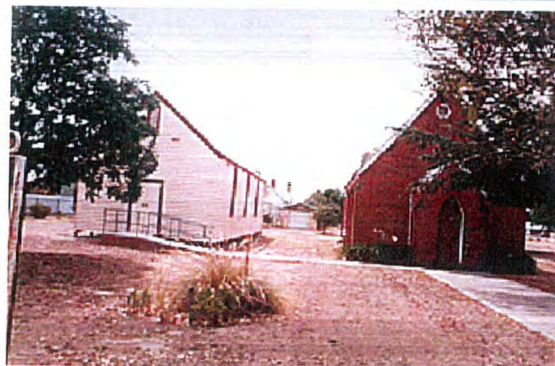
Externally the buildings appear to be in good condition.

It is recommended that Scots Church and Church Hall McLachlan Street, Carisbrook be retained on the Heritage Overlay of the Central Goldfields Planning Scheme.

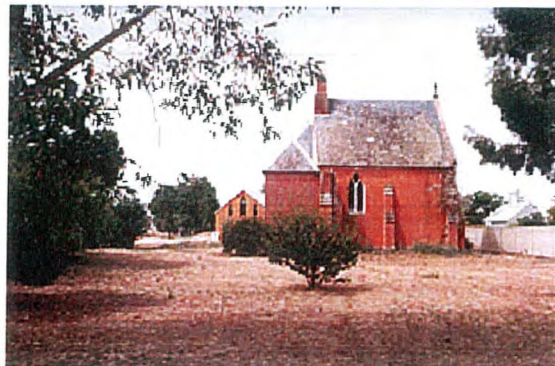
The part that is now closest to the rear fence is a simple brick, two-bay nave with stepped brick buttresses. The roof is a steep gable, clad in slate, with a cross on one gable apex and the other apex surmounted by a brick bellcote containing a bell. The rear gable end is capped with a short raking parapet and appears to be the finished rear (or possibly front) wall of the design. The end with the bellcote is unfinished with the roof dividing into two gables now clad in rusted metal cladding. One bay has a pointed arched window with glazing bars dividing into two arched sections.

The building appears in fair to good condition externally.

It is recommended that the former Church of Francis Xavier, McNeil Street, Carisbrook be retained on the Heritage Overlay of the Central Goldfields Planning Scheme.

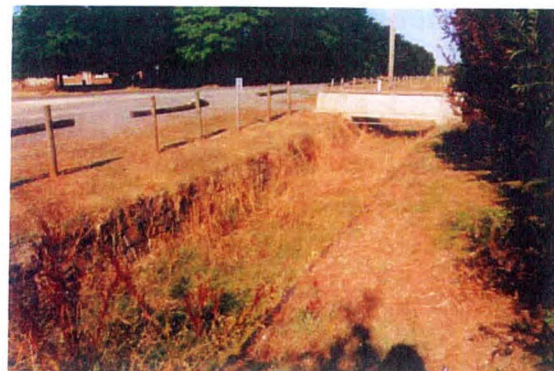
The bluestone gutters in Bucknall Street (and in other areas) of Carisbrook are of technological, aesthetic and historical significance at a local level. The gutters demonstrate the community's work through the council to provide a better living environment and demonstrate the nineteenth century technology for dealing with drainage problems. The

bluestone street gutters add to the significance of the township and enhance the historic significance of buildings within the streets where they are retained.

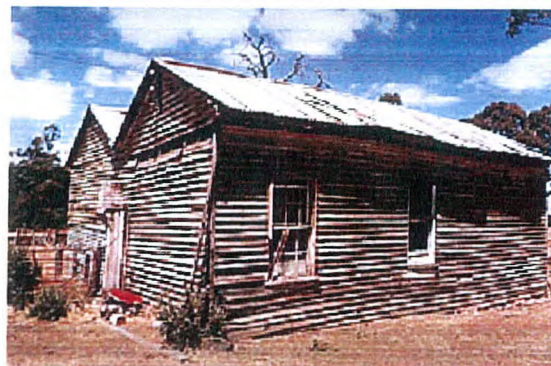
CP05

Condition The building is in poor condition.

Recommendations It is recommended that the former Charlottes Plains Hotel Carisbrook-Eddington Road, Charlotte Plains be recommended for addition to the Heritage Inventory administered by Heritage Victoria.

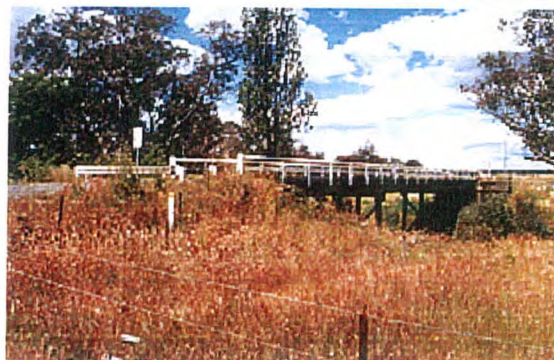
Cr01

Condition The bridge is in fair to good condition.

Recommendations It is recommended that Masons Bridge, McCallums Creek, Maryborough-Majorca Road, Craigie be protected under the Heritage Overlay of the Central Goldfields Planning Scheme

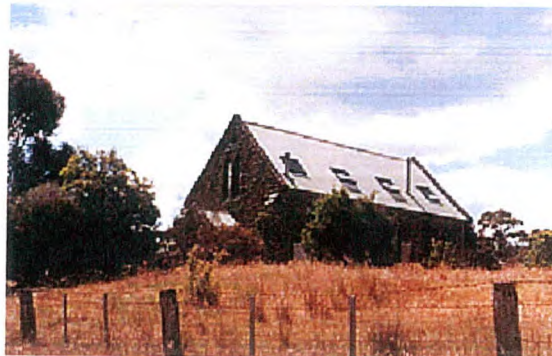
Cr03

Condition	Externally the main form, roof and walls are in good condition.	
Integrity	The main form and wall materials of the building survive but the building has been altered by the addition of roof and wall openings.	
Recommendations	It is recommended that the former Majorca Methodist Church, Majorca-Maryborough road, Majorca be protected under the Heritage Overlay of the Central Goldfields Planning Scheme.	
References	Bette Bilton, local resident; 'Spectator', May 19th, 1905	
Assessed by:	WJ, RB	February 2002

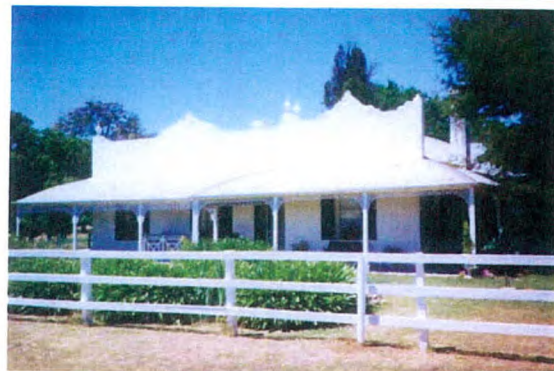
The main house is set on a relatively flat site with some remnant garden and mature exotic trees. The house has a main facade of rendered brick with a large decorative parapet with two decorative free form pediments and rising to each corner which terminate in orb finials (one now missing). The roof is of intersecting gables with brick chimneys now painted. Springing from the parapet front is a deep verandah with a convex roof form. This is supported on recent timber posts and there is what appears to be a recently introduced cast iron valance and brackets. The verandah returns along both sides of the brick section with a change in roof form – on one side it becomes an extension of the roof and has a skillion roof form. The brick section has an asymmetrical facade with one section coming forward with a wide central timber double hung window. The main entry is adjacent to the protruding bay and there are two timber double hung windows to the other side of the door. The brick section has been extended by the addition of a timber wing to one side set back from the original frontage. This terminates in a transverse gable with the gable end aligned with the main elevation. The roofs are clad in corrugated steel. The walls are clad in square edged weatherboards and there are timber double hung windows.

The garage building has a similar roof pitch to the barn but is a smaller building. It has a corrugated steel clad roof and weatherboard clad walls. There is a slated rectangular vent in the gable end and a nine paned, timber double hung window in the side.

The dairy would appear to date from the early twentieth century as it has a concrete base and a gable roof with deep eaves and gable end overhang to keep the building cool. The building is clad in cement sheeting and has a timber diagonal boarded entry door in the

The former piggery has a steeply pitched hipped roof and vertical timber slab walls. This building form and materials is associated with early pastoral settlement. It is a very simple form of building. The large slab walls could be readily procured from surrounding timber and the construction materials and methods did not rely on manufactured materials. This may be an early dwelling erected while the brick building was built or prior to its construction

The house is in good condition. The outbuildings are in fair condition for their age.

Recommendations It is recommended that Hampstead Park, Carisbrook-Talbot Road, Craigie be protected under the Heritage Overlay of the Central Goldfields Planning Scheme.

Additional research may indicate that this building is of sufficient historic significance to recommend for addition to the Victorian Heritage Register. It is recommended that further historical research and detailed physical inspection be undertaken.

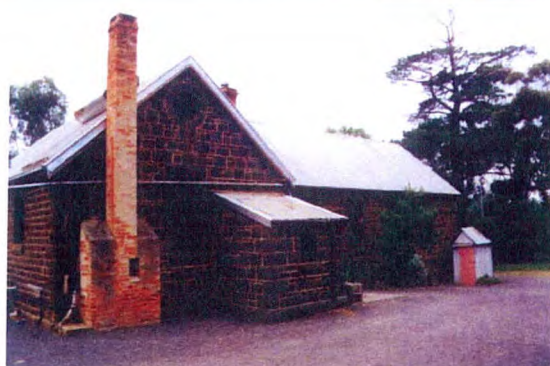
Cr07

Near the main building are two small bluestone toilet buildings with gable roofs clad in corrugated steel. One has had some stone fall out of the side wall. The other has extensive cracking.

The building appears to be externally in good condition. The toilets are in poor condition.

It is recommended that the former Craigie State School, Maryborough-Majorca Road, Craigie be retained on the Heritage Overlay of the Central Goldfields Planning Scheme.

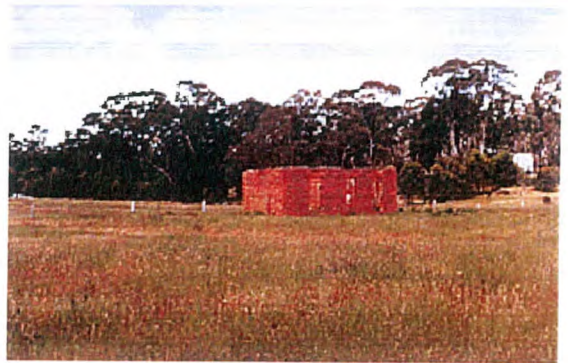
The former Havelock School site is historically and socially significant at a local level. The site reflects patterns of settlement in township and area. The site was a major community

centre during the era of the school occupation. The trees are significant as memorials to events held as important to the local residents at the time of planting.

Recommendations The timber sign and plantings should be retained as memorials to the earlier use of the site.

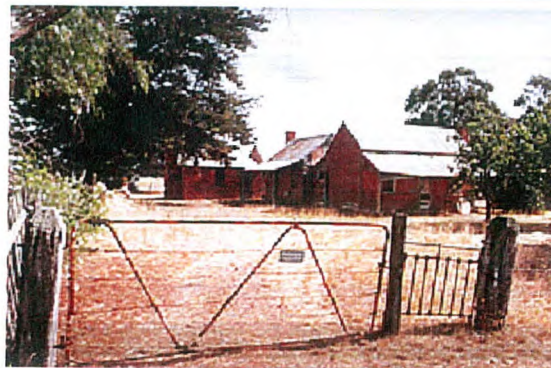
House (unoccupied)

Condition The condition is poor.

Recommendations It is recommended that the place is noted as Conservation Desirable and assistance is given to owners wishing to retain the building.

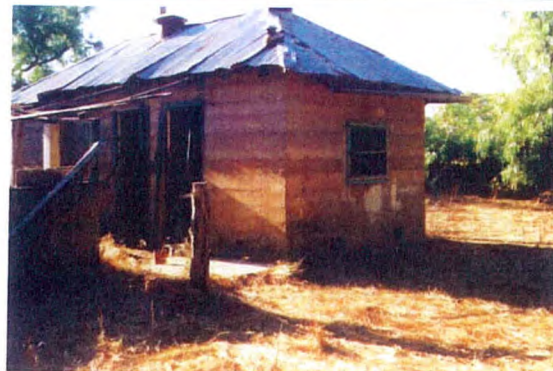
Farmhouse complex (abandoned)

The outbuildings comprise a collection of gable roofed and skillion roofed buildings and include an old cast iron boiler for water storage. These boilers were generally originally made to power gold mining machinery and after mines closed are found as water storage on nearby farms.

The condition of the farmhouse is fair to poor. The condition of the outbuildings is fair to poor.

It is recommended that this place be protected under the Heritage Overlay of the Central Goldfields Planning Scheme

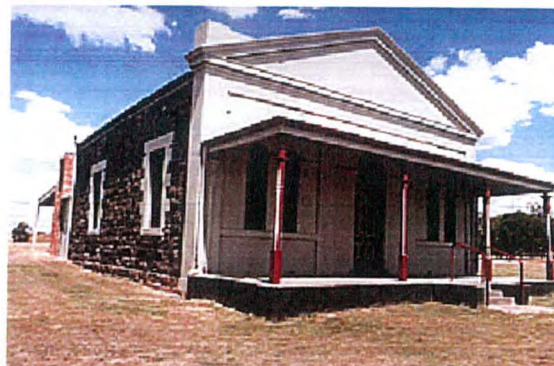
M02

The Majorca Town Hall, designed by Charles Toutcher and constructed in 1876 by Joaac Mavorcous, was erected for the recently formed Borough of Majorca after the previous council premises were burnt down. Apparently, Charles Toutcher as Clerk of Works did not supervise the building program effectively, and John Duke replaced him. Furniture for the new town hall was supplied by Phelans in Maryborough and consisted of 18 cane-botomed oak arm chairs, one 6 foot x 4 foot leather covered cedar table, one 6 foot x 4 foot cedar table, five chandeliers and venetian blinds for all windows.

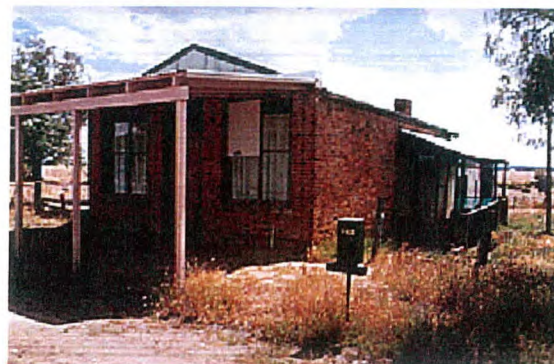
M05

Condition The building is in fair condition.

Recommendations It is recommended that the former shop, Main Road, Majorca be protected under the Heritage Overlay of the Central Goldfields Planning Scheme.

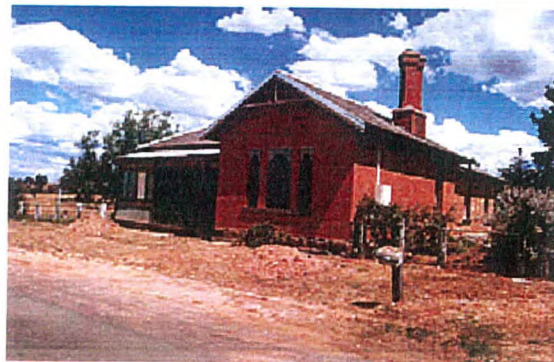
M08

The building is in good condition.

It is recommended that the former Majorca Post Office, Galloways Road, Majorca be retained on the Heritage Overlay of the Central Goldfields Planning Scheme.

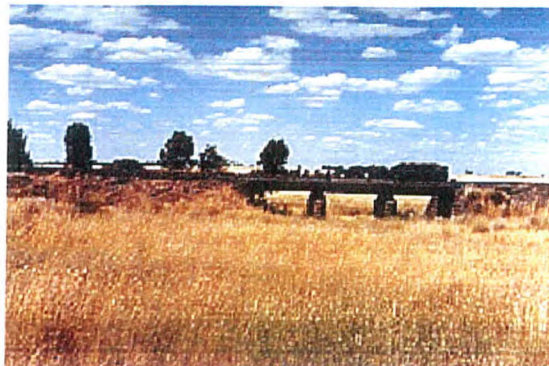
Condition	The bridge is open to traffic and its condition is good.	
Integrity	The integrity is high.	
Recommendations	The bridge is recommended for inclusion in the Heritage Overlay of the Central Goldfields Shire Planning Scheme.	
References	Victorian Railways Bridges File.	
Assessed by:	AW	October 2001

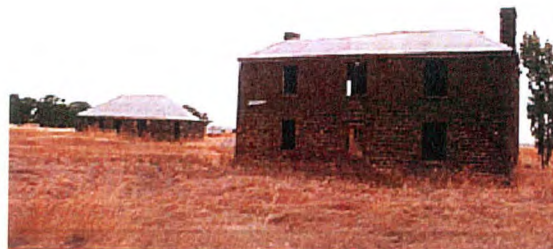
The bluestone two storey former McLay farmhouse and outbuilding, Pyrenees Highway, Moolort is of historical significance at a local level. It represents an early farming complex dating from the mid nineteenth century. The building is also associated with J. McLay an early Councillor of the Shire of Tullaroop.

The bluestone two storey former McLay farmhouse, Pyrenees Highway, Moolort is of

aesthetic significance at a local level. The simple two storey Georgian design of the farmhouse and the use of local stone is characteristic of this era. The form, materials, fenestration, chimneys and layout of the farmhouse and outbuildings all demonstrate the design characteristics of this era.

Condition	The buildings are in poor condition.
Integrity	The buildings are missing some building fabric and are moderately intact.
Recommendations	It is recommended that the bluestone two storey former McLay farmhouse, Pyrenees Highway, Moolort be protected under the Heritage Overlay of the Central Goldfields Planning Scheme.
References	Willis, Barbara, Footprints: A History of the Shire of Tullaroop, Shire of Tullaroop, Maryborough, 1988, p. 19
Assessed by:	WJ, RB May 2002

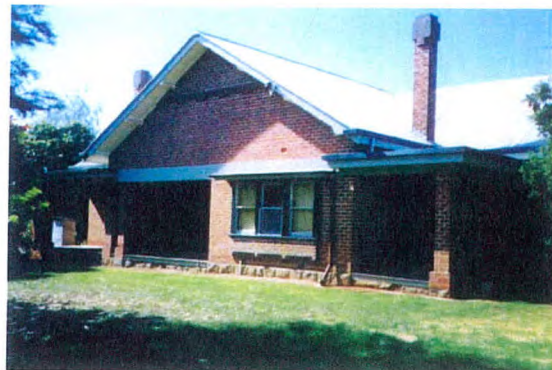
Stranraer, Pyrenees Highway, Moolort, is of aesthetic significance at a local level as it demonstrates the qualities of buildings in the interwar era especially the use of brickwork in a decorative manner, the response to the Australian climate with the use of deep eaves and sheltering verandahs, the slender brick chimneys and timber double hung windows.

Condition The house and outbuilding appear externally to be in good condition.

Integrity The house and outbuilding appear to be substantially intact.

Recommendations It is recommended that Stranraer, Pyrenees Highway, Moolort be protected under the Heritage Overlay of the Central Goldfields Planning Scheme.

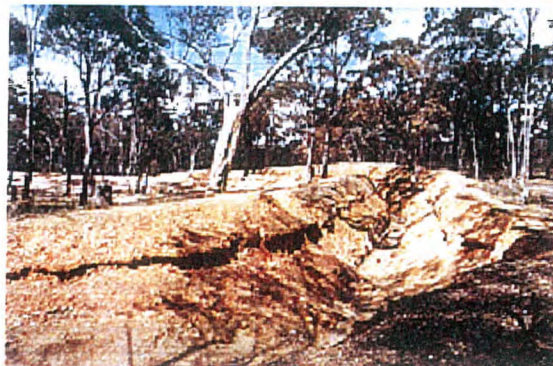
Mq01

Description	<p>The Carisbrook reservoir, State Forest, Mosquito Flat consists of a earth dam wall, bluestone bye-wash and earthen contour drain in a valley area surrounded by lightly timbered hills. The earth wall still retains water and approximately 135 metres of the bluestone bye wash remains substantially as described in the original specification. The later addition of the earth walled contour drain still exists in good condition.</p>
History	<p>A scarcity of clean water supplies at Carisbrook, caused by silting from mining activity, gave impetus to the formation of the Carisbrook Water Trust in 1892.</p> <p>The Trust oversaw the building of a reservoir at Mosquito Gully in 1892. Built on land purchased from Jane and James Spedding some three miles from Carisbrook, the Mosquito Gully Reservoir was designed by engineers Messrs Gale and Parker, and constructed by contractor William Bruce from Oakleigh for a sum of £3044 1s. 10d. The earth dam required a wall of 1195 feet, with a maximum height of 20 feet, a puddle trench, puddle wall, outlet works, fore bay, timber gangway to outlet valve, a bye-wash and other minor works.</p> <p>The bluestone bye-wash was built to the following specifications (only part of a 15 page description):</p> <p>"The pitchers to be squared bluestone...nine inches deep. The side rows at bottom to have one arris knocked off to form skewback for pitchers on the side slopes. The pitchers to be set lengthwise across the channel in bottom and lengthwise in channel on slopes, in proper bond, all to be bedded on, and set in full mortar, and the bottom to be thoroughly grouted in, so as to fill all remaining voids. Concrete in drop and curtain wall to be of the forms shown both as to lines and levels. Exposed surfaces of concrete to be rendered floated and set as specified for mortar."</p> <p>The squared pitching as described above was costed at 5 shillings per super yard by 477 super yards, a total of £369 5s.</p> <p>The contract for the pipeline and reticulation of Carisbrook was let to Messrs Gray, Russel and Bassett of Kyneton for £3637 17s. 5d. in October 1892.</p> <p>The drought years of 1895-1902, however, impacted on the capacity of the Reservoir to supply an adequate water supply to Carisbrook. Subsequently, a contour drain was built in</p>

The earth embankment, bluestone bye wash and earthen contour drain appear in good condition.

It is recommended that the Carisbrook Reservoir, State Forest, Mosquito Flat be protected under and the bye-wash retained on the Heritage Overlay of the Central Goldfields Planning Scheme.

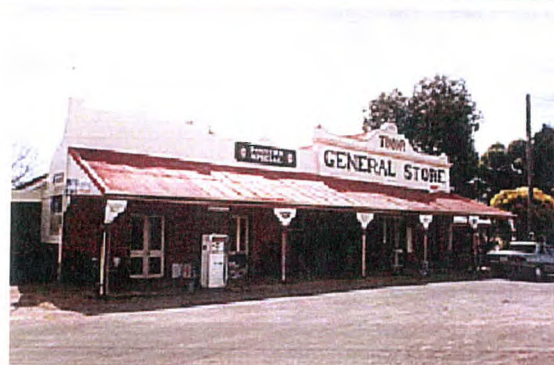
T09

The Timor General Store, residence and timber lock up, corner of Bet Bet Creek and Timor Road, Timor is part of the streetscape of the Timor township. The store is on a relatively flat site and is placed on the street boundary. The brick store has a parapeted street facade with a wide skillion roofed verandah supported on large timber posts. The right hand section of the building, built in 1870, has a high parapet rising to pedestals at each end and to an arched and curved pediment in the centre which conceals the apex of the gabled roof behind. The side pedestals appear to be missing decorative orbs or urns. The parapet has a decorative string course near the top. The left hand side parapet is lower and of plainer design and would appear to be the additions of c1900. This marks this section of the building into two parts with each part having a central stepped brick section and the ends marked by pedestals. Below the verandah the walls are of face red brick. The right hand section has a central entry with a pair of timber doors. Either side is a wide timber frame shop window. The left section has a pair of timber doors to the far left, another single entry door near the centre and a timber framed window to the right. The residence is set back from the street behind a garden area and is adjacent to the shop on the right.

The timber lock up is an example of the portable lock ups found in country Victoria, especially in the gold fields with their rapid expansion of population and sudden shifts of population. They were constructed as a cage with steel bars through the walls and floor and very thick timber slabs lining the walls, floor and ceiling. They typically had very heavy timber doors with the only openings being small barred vents high under the eaves. The ceiling space was ventilated through the louvred gable ends. The building is roofed in corrugated metal. These lock ups are becoming increasingly rare due to lack of maintenance and insect attack.

The store, residence and lock up appear to be in fair to good external condition.

It is recommended that the Timor General Store, residence and timber lock up, corner of Bet Bet Creek and Timor Road, Timor be protected under the Heritage Overlay of the Central Goldfields Planning Scheme.

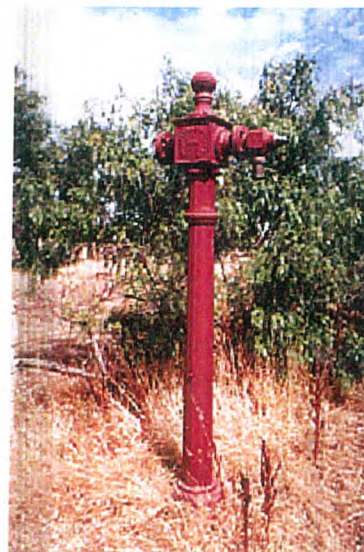
Standpipe

Description The pipe stand in Timor Road, Timor consists of a round fluted column and horizontal arm with a tap wheel. The column has a moulded cast iron base. The square cast iron box connecting the horizontal arm to the columns is surmounted by a cast iron orb on a flared base.

Condition The pipe stand appears to be in good condition.

Recommendations It is recommended that the pipe stand in Timor Road, Timor be retained on the Heritage Overlay of the Central Goldfields Planning Scheme.

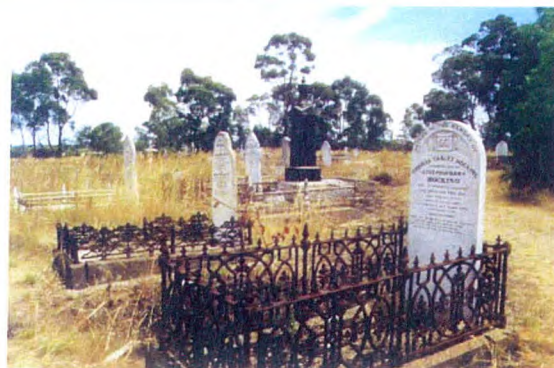
The Timor Cemetery, Maguire Road, Timor is on a gently sloping site in a rural setting. There are some sugar gums planted at the boundaries and a number of mature gum trees within the reserve. The site has a post and wire fence with entry pedestrian and vehicle gates of wrought iron and chain wire mesh supported on timber posts which would appear to date from the interwar period. The cemetery is laid out in denominational plots and there is a central planted area of recent date containing lilacs, peppercorns and rosemary. The graves are adorned by marble and granite headstones and in some instances wrought and cast iron grave fences. There are many unmarked graves and some with remnant timber surrounds and headstones. The headstones record the deaths of mining accidents in 1874 and 1876. The headstones also reflect the large number of cultures represented on the goldfields.

Condition The cemetery is in fair condition.

Recommendations It is recommended that the Timor Cemetery, Maguire Road, Timor be protected under the Heritage Overlay of the Central Goldfields Planning Scheme.

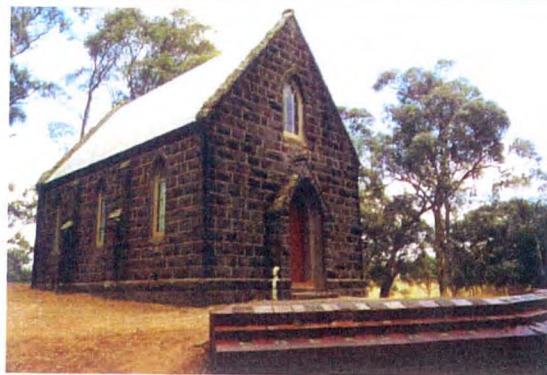
Description The Bucknall Family Memorial Church, beside Tullaroop Dam, Rodborough, is a small bluestone church erected in 1882 by Mrs William Bucknall as a memorial to her husband who died in 1878. The church is a rectangular building of squared rusticated bluestone laid in even courses on a stepped plinth. The steeply pitched gable roof is clad in lapped corrugated iron. The three bay church has a narrow gabled entrance porch with an arched window above. The bays are marked by stepped buttresses with a single lancet window in the middle of each bay. 'New Church' is inscribed in stone above the front entrance.

Condition	Bucknall Family Memorial Church, beside Tullaroop Dam, Rodborough, is in good condition. The surroundings of the church have changed radically in recent years with the creation of the Dam.
Integrity	The building is substantially intact.
Recommendations	<p>It is recommended that the Bucknall Family Memorial Church Rodborough be recommended for addition to the Heritage Register of Victoria.</p> <p>It is recommended that the Bucknall Family Memorial Church Rodborough be retained on the Heritage Overlay of the Central Goldfields Planning Scheme and retained on the Registers of the National Estate and National Trust.</p>
References	Bucknall, Charles, Rodborough Vale: The Rural Story; Second Impression, 1994, passim; Bucknall, Graeme, and McDonald, Lorna, Letters of an Australian Pioneer Family 1827-1880, The Association of the Bucknall Family, Carisbrook, 1984, passim; Richard Bucknall, family member; Registers of the National Estate and National Trust
