# Conservation Management Plan

## Maryborough Municipal Olympic

### Swimming Pool Complex

**April 2018**

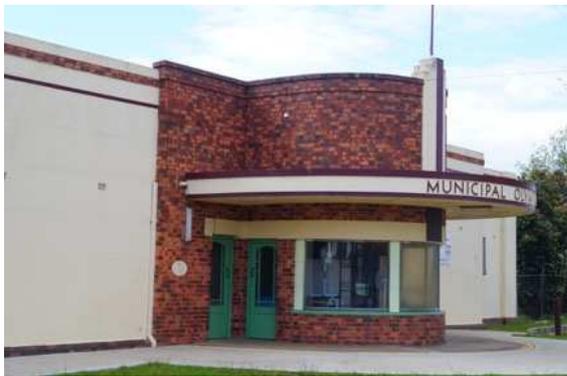
Due to war time shortages of funding and materials no reinforced concrete foundations were included. The walls were built directly off the clay ground. Sometime later, underpinning in the form of reinforced concrete pads were located at each corner wall junction, indentation and projection.

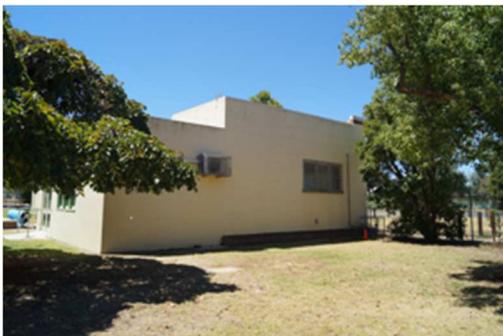
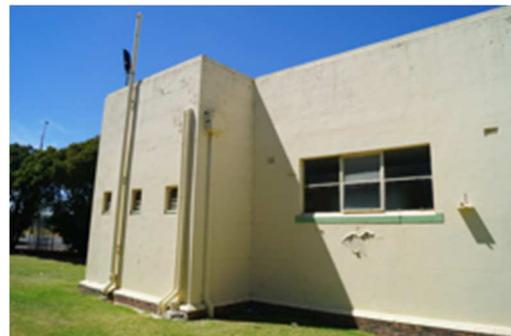
The minimal use of reinforced concrete footings meant that over time the build developed substantial cracks in the walls.

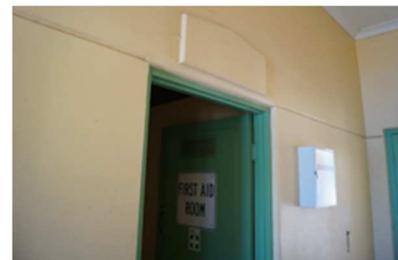
The internal wall clearly shows the line of new render repairs and also the height at which the salts rise in the wall before coming out of the brickwork. The First Aid Room is on the left of the public passage.

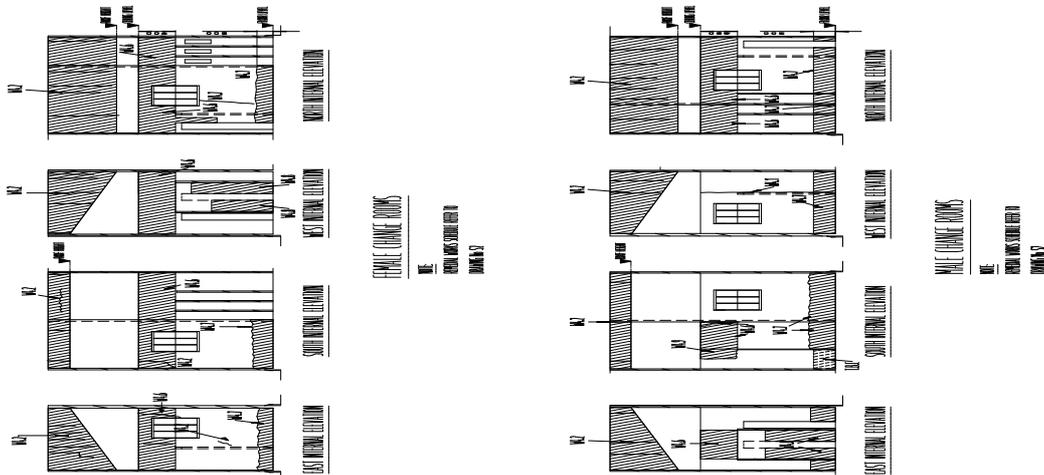
The walls consist of single leaf face brick and inner reinforced concrete blocks. Internally, remedial work has included removal of damaged plaster, re-rendering and re-painting to the upper wall surfaces where there was substantial cracking. In addition, re-plastering occurred in the lower wall section following the injection of the new damp proof.

Drawings and structural remedial design by Hogg Beauchamp and Spano Pty Ltd.

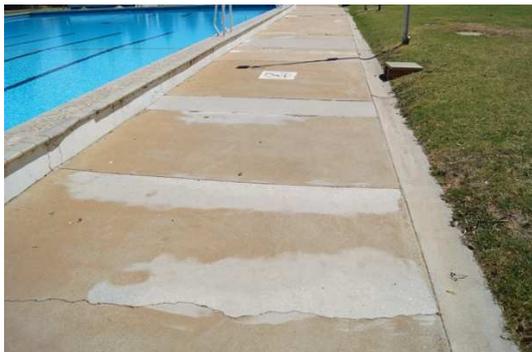
Maintenance is meticulous as each year new sections of the concourse is re-laid in strips, and uneven surfaces ground down. The tiniest crack and imperfection have been repaired, way beyond the natural life of the original concrete fabric. However, the concrete paving around the main pool continues to be subject to regular cracking and uneven settlement.

View of the concrete concourse.

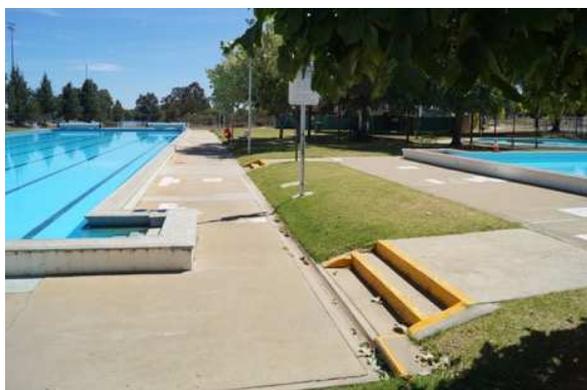
Photograph taken in January 2018  
When the pool is open to the public.

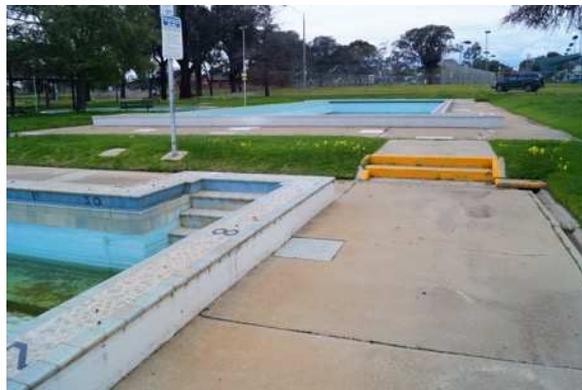
Photograph taken in April 2017  
When the pool is closed to the public.

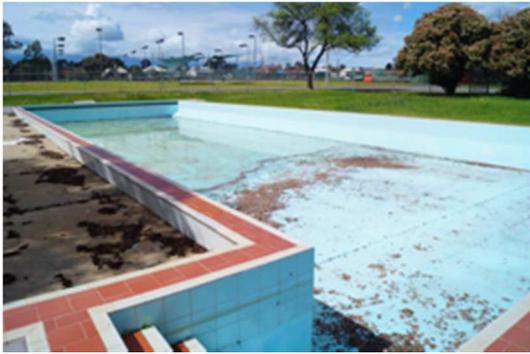
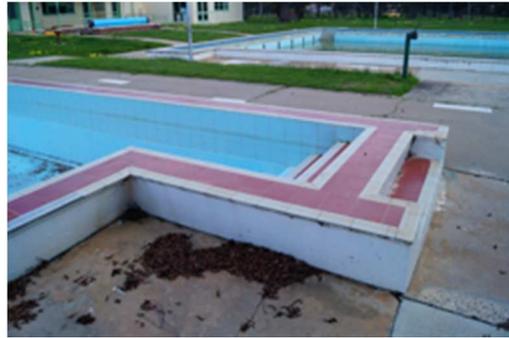
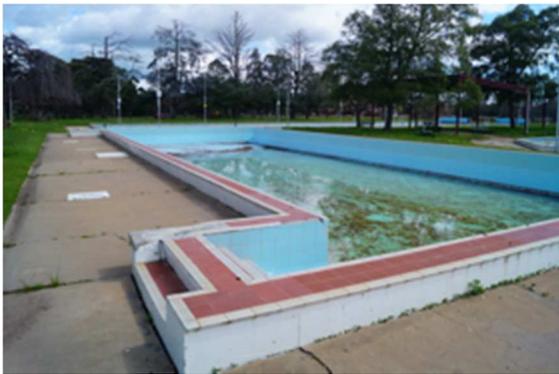
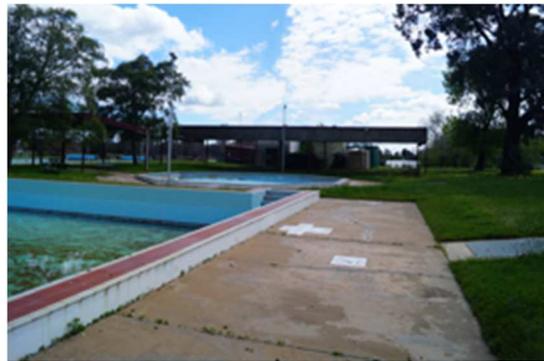
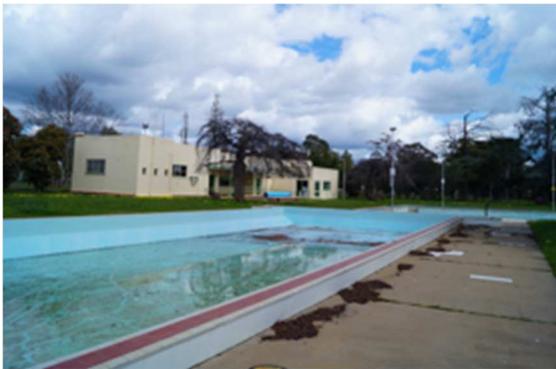
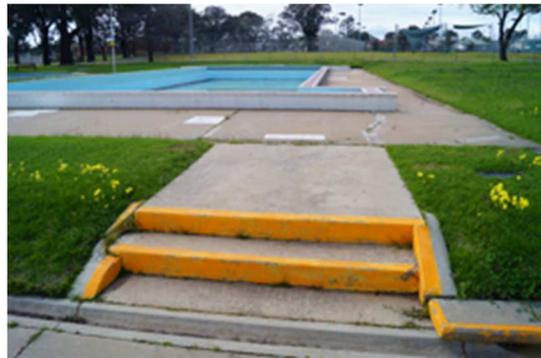
The learn to swim pool is generally considered to be in much better condition than the other pools. However, the bulkhead tiles have become damaged and have delaminated in multiple locations. A large number of bulkhead tiles are either cracked or delaminated around the pool. [92, 98]. There are some slight cracks in the wall of the pool and across the filtered water return cover. [104, 105]

View of the basin of the Intermediate Pool during winter and while maintenance of the pool is in progress.

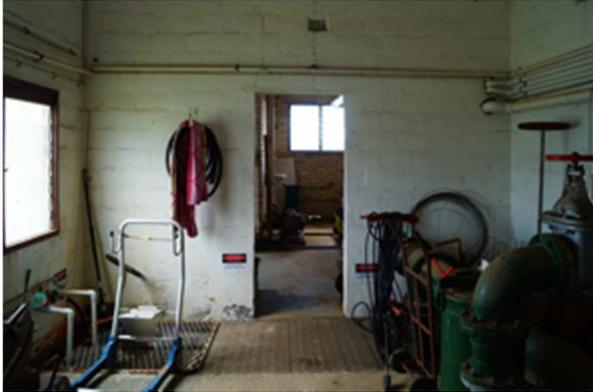
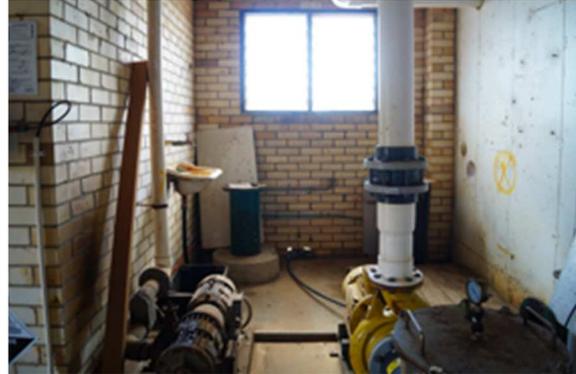
For the purpose of this report this room is located on the western side of the plant room. The pump room is located above the western side of the balance tank. There are a number of chemicals stored in this room without bunds (sodium bisulphate and cyanuric acid. Both of these items are in powder form).

Liquid acid (hydrochloric acid) is also stored in this room. The liquid acid is not stored in a bunded area and there are trip hazards between the acid storage and where it is in use [121, 122]. There is also an electrical switch board and sink located in the pump and testing room.

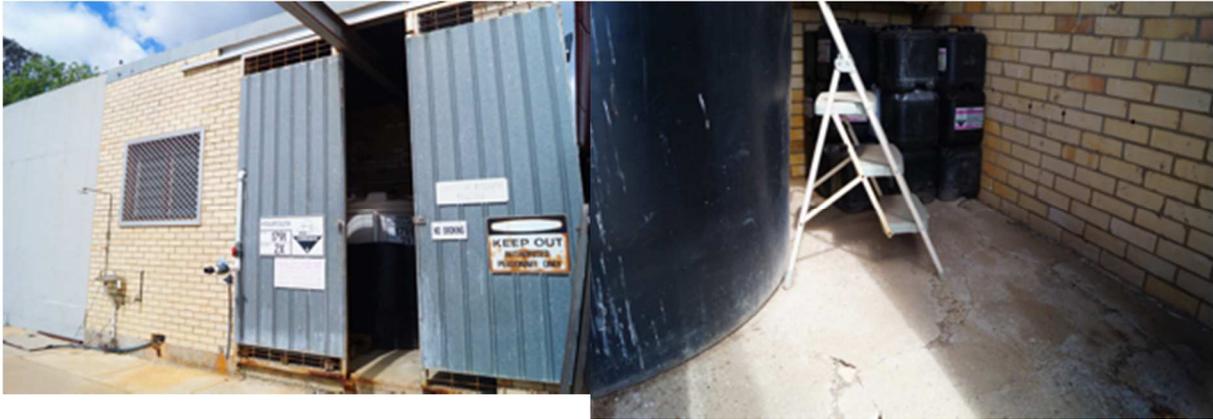
For the purpose of this report this room is located north of the plant room. There is a redundant chlorine storage room in the north-eastern corner of the plant room (above the balance tank).

There is also a redundant chlorine storage room with a badly spalled concrete floor. The chlorine storage room consists of a small veranda style enclosure with 'shade cloth' walls.

- The redundant chlorine storage room floor is suffering from a large amount of concrete spalling due to severe corrosion of the steel. The top steel in this room is no longer effective as it has corroded so badly. There was also a large amount of steel corrosion leaching visible from within the balance tank in the same area. There is also horizontal cracking noted around the balance tank hatch opening.

- The damage to the roof of the balance tank / chlorine storage room floor is severe. The room should be sealed and do not enter signs attached to the access point as it is considered unsafe by FMG. The floor is likely not repairable and requires removal and replacement.

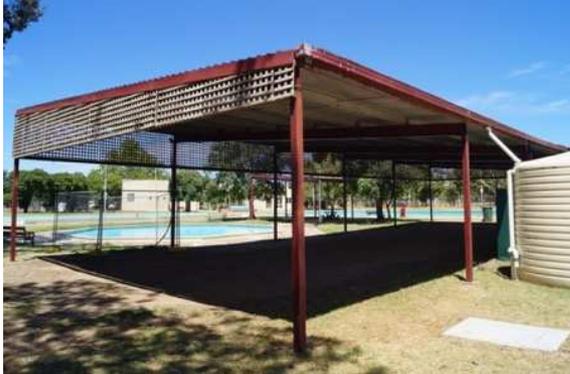
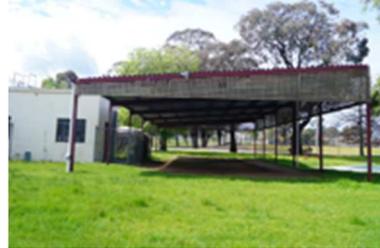
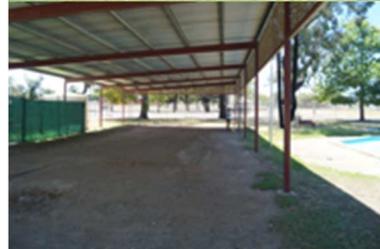
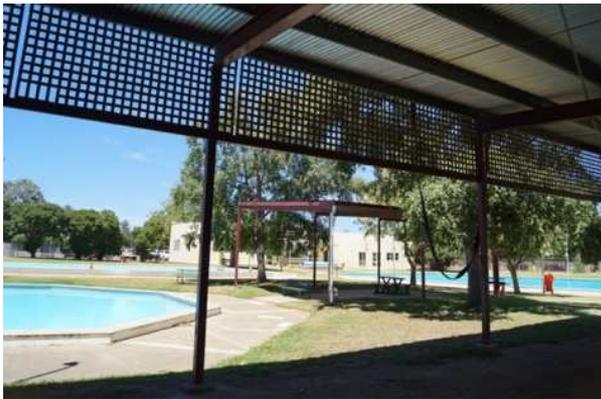
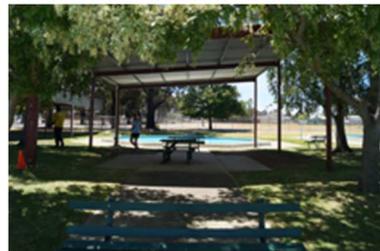
The shade shelter was originally constructed in the 1990s to house the solar panels which were to heat the pools. The units have not been used for over twenty years.

The large rectangular shade shelter is unsightly. The dirt floor is rough and uneven, subject to water logging and a source of dirt and dust. It is a hazard as dirt and mud is carried into the Octagonal Wade Pool. The shade shelter is not popular among users.

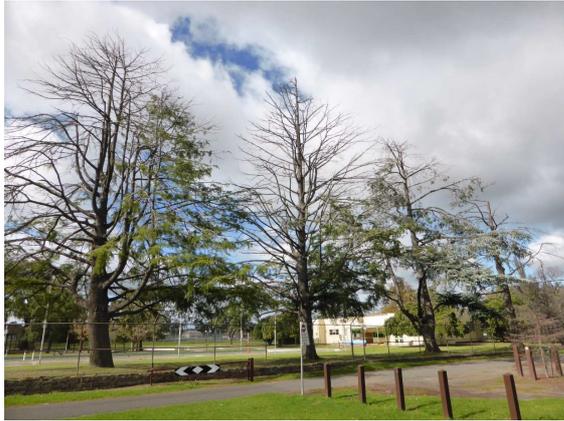
T2 to T5

T1	<i>Cedrus deodara</i> 'Aurea	major dieback, poor condition
T2	<i>Cedrus deodara</i>	major dieback, poor condition
T3	<i>Cedrus deodara</i>	major dieback, poor condition
T4	<i>Cedrus atlantica</i> f. <i>glauca</i>	major dieback, poor condition
T5	<i>Cedrus deodara</i>	major dieback, poor condition
T6	<i>Ulmus glabra</i> 'Camperdownii'	good condition
T7	<i>Cupressus torulosa</i>	tree removed
T8	<i>Cupressus torulosa</i>	tree removed
T9	<i>Ulmus glabra</i> 'Camperdownii'	good condition
T10	<i>Hesperocyparis glabra</i>	tree removed
T11	<i>Eucalyptus sideroxylon</i>	good condition
T12	<i>Eucalyptus sideroxylon</i>	good condition
T13	<i>Fraxinus angustifolia</i> subsp. <i>angustifolia</i>	good condition
T14	<i>Acer negundo</i>	good condition
T15	<i>Acer negundo</i>	good condition
T16	<i>Alnus acuminata</i> subsp. <i>glabrata</i>	good condition
T17	<i>Alnus acuminata</i> subsp. <i>glabrata</i>	good condition

- T1 - Cedrus deodara 'Aurea', T2 & T3 - Cedrus deodara x2,
- T4 - Cedrus atlantica f. glauca, T5 - Cedrus deodara
- Remove and replant all trees with the same species, 1m east of existing trunks
- Plant a Cedrus atlantica f. glauca between trees #1 and #2
- Mulch all trees
- Provide tree guard if required

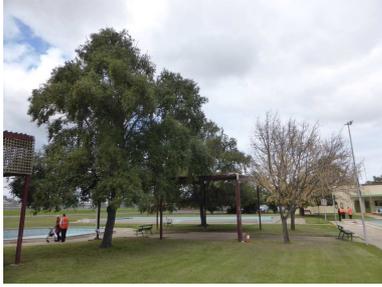
T14 Acer negundo rhs, behind  
 T15 Acer negundo rhs, front  
 T16 Alnus acuminata subsp. glabrata lhs, behind  
 T17 Alnus acuminata subsp. glabrata lhs, front  
 Remove 1-2m grass strip around trunk and mulch

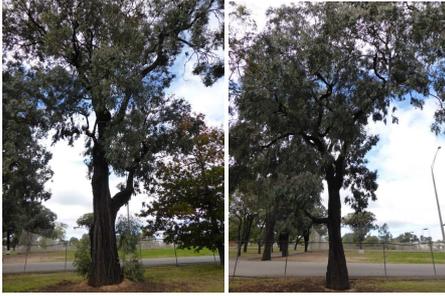
T11 Eucalyptus sideroxylon  
 Remove basal shoots from T11  
 T12 Eucalyptus sideroxylon

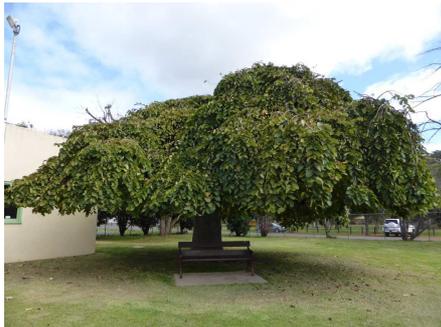
T6 Ulmus glabra 'Camperdownii'  
 Remove 1-2m grass strip around trunk and mulch

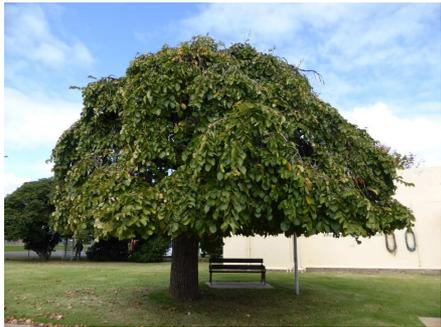
T9 Ulmus glabra 'Camperdownii'  
 Remove 1-2m grass strip around trunk and mulch

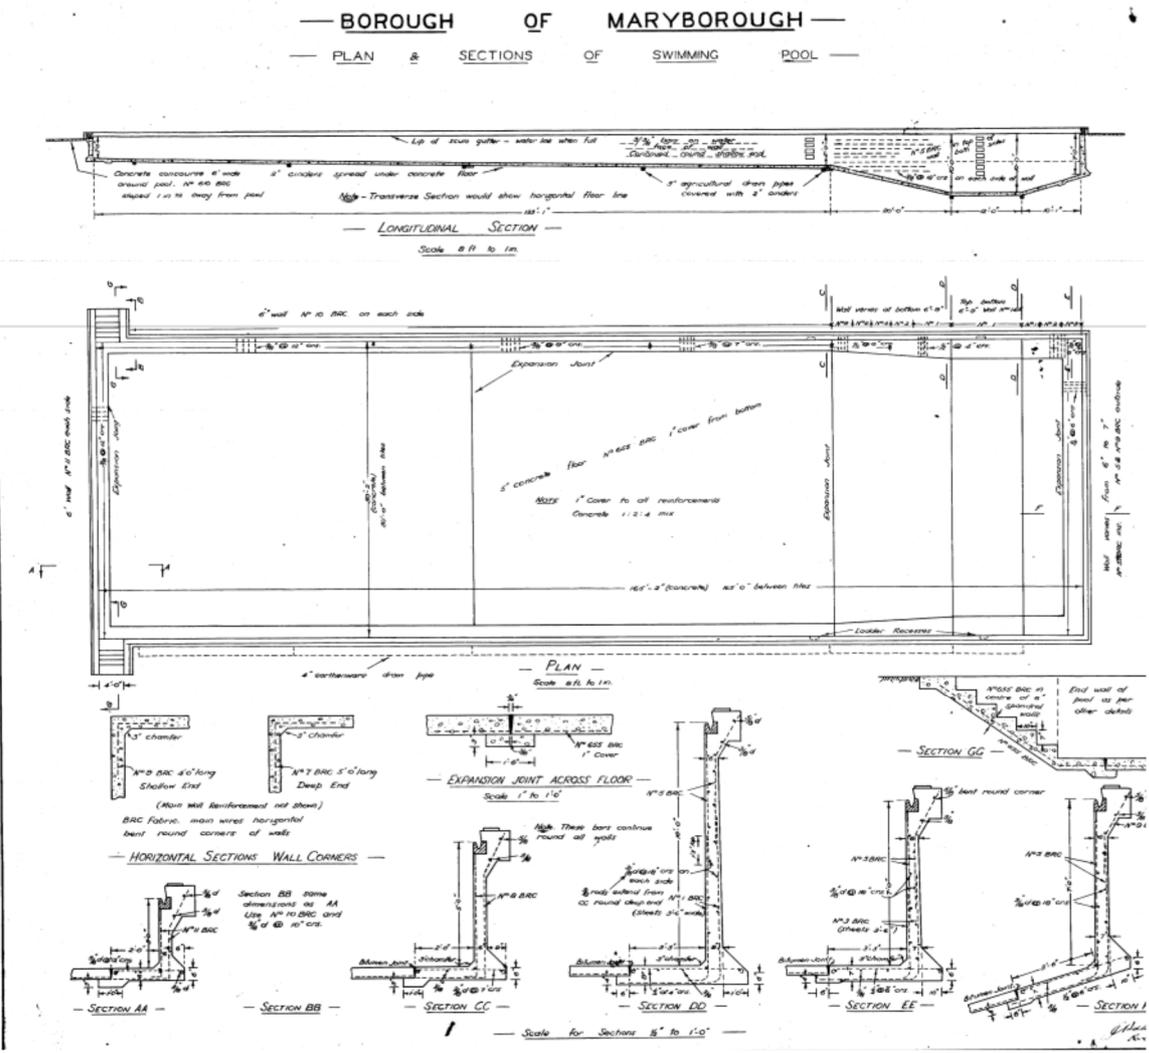
Previous Priority Works for Structural Remediation in the Olympic Pool in 1972.

Plan of the Maryborough Olympic Swimming Pool showing the remedial work to pool concrete basin and expansion joints in 1972 drawn by the City of Maryborough Engineering Department.

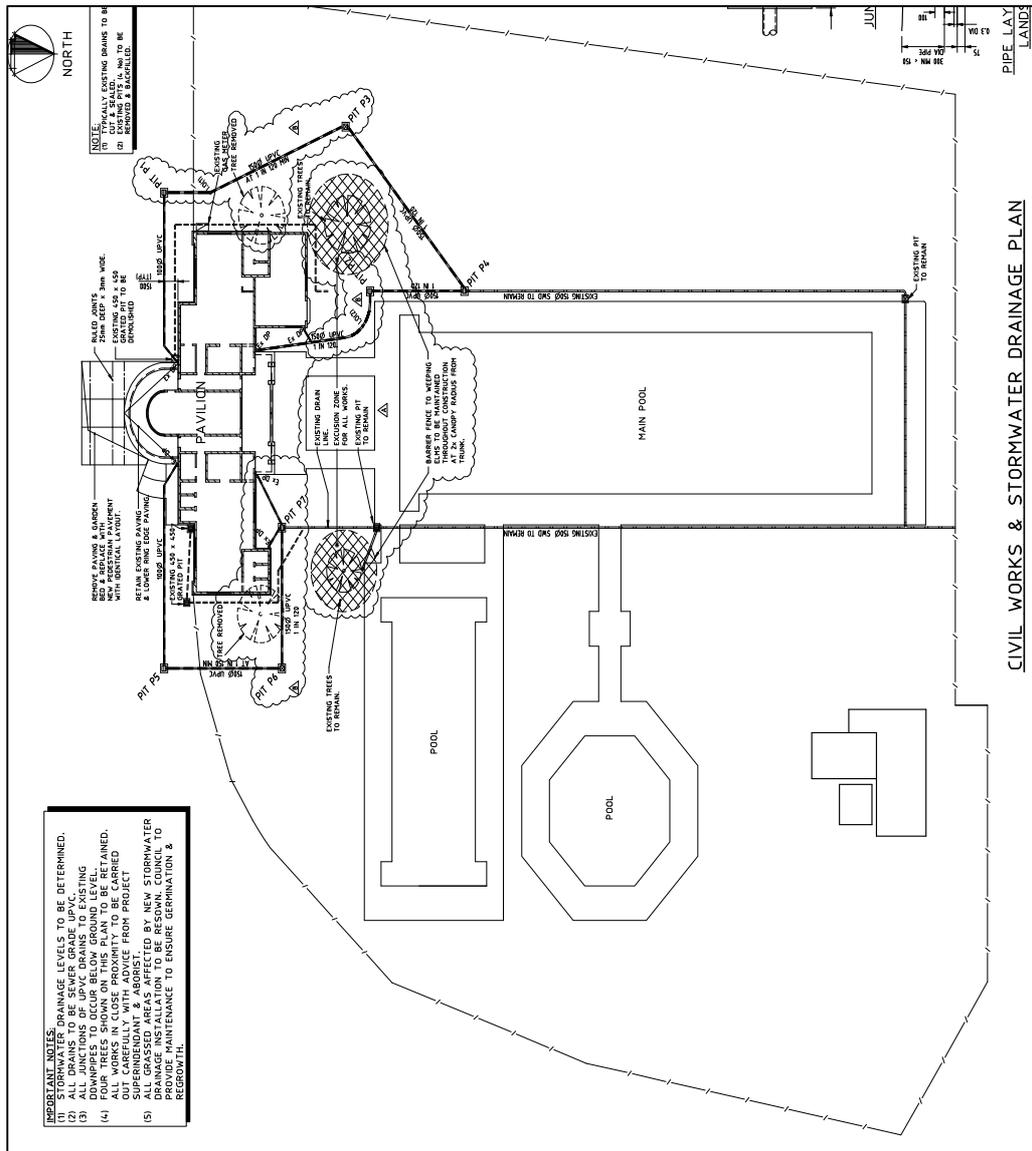
**Repair of the Concourse to specifications and schedules previously prepared by Beauchamp Hogg & Spano Pty Ltd., 2002.**

All to specifications and schedules previously prepared by Beauchamp Hogg & Spano Pty Ltd., 2002. The above works were carried out in 2000 for the repair of the stormwater and concrete concourse around the Pool area.
