INVESTIGATION AND DESIGN OF CARISBROOK FLOOD AND DRAINAGE MITIGATION TREATMENTS

# Detailed Design Report

ENTURA-A31FA 6 June 2016

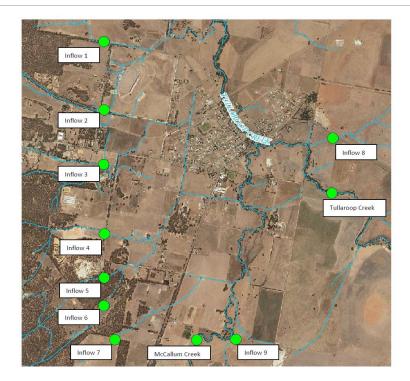
Figure 5.1: Extracted from Water Technology Report (2011); location of RORB extracted hydrographs around Carisbrook

Based on Figure 4-3 of the Water Technology Report (2011) which is shown in Figure 5.1, the MIKE Flood model has 11 inflow locations the hydrographs of which were extracted from a RORB model.

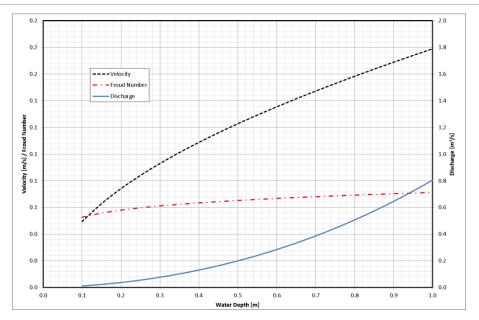
Figure 5.2: Hydraulic characteristics of the trapezoidal channel with a longitudinal slope of 0.00003

Summary of the levels and longitudinal slopes of the channel is provided in Table 5.8. The hydraulic calculations associated with different slopes are provided in Figure 5.2 to Figure 5.8. A manning's coefficient of 0.022 has been considered for the calculations. It should be noted that all the channel segments are categorised hydraulically as Mild (M) and the water profiles at the intersections between them would be M1 and M2 curves.

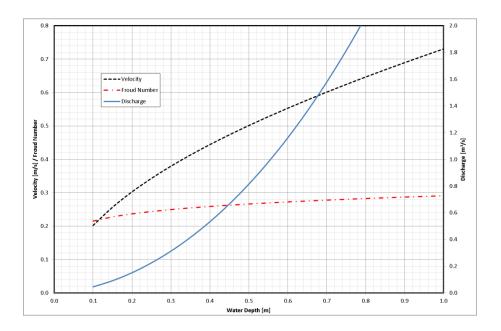
Figure 5.3: Hydraulic characteristics of the trapezoidal channel with a longitudinal slope of 0.0005

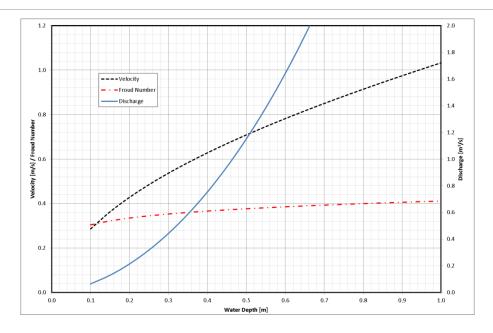
Figure 5.4: Hydraulic characteristics of the trapezoidal channel with a longitudinal slope of 0.001

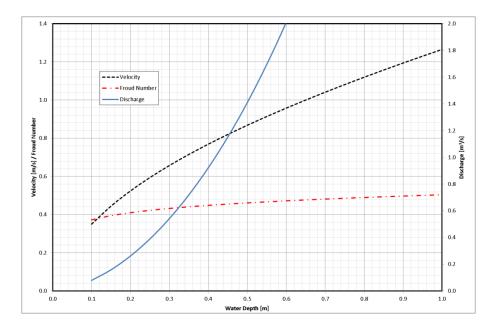
Figure 5.5: Hydraulic characteristics of the trapezoidal channel with a longitudinal slope of 0.0015

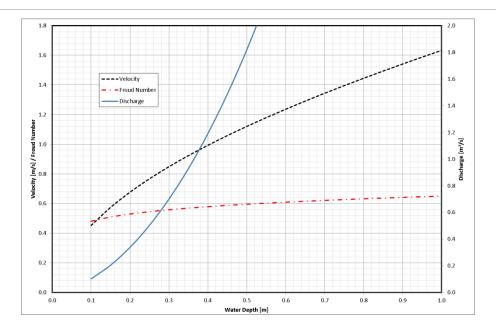
Figure 5.6: Hydraulic characteristics of the trapezoidal channel with a longitudinal slope of 0.0025

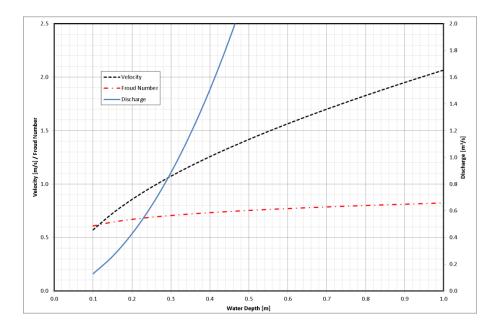
Figure 5.7: Hydraulic characteristics of the trapezoidal channel with a longitudinal slope of 0.004

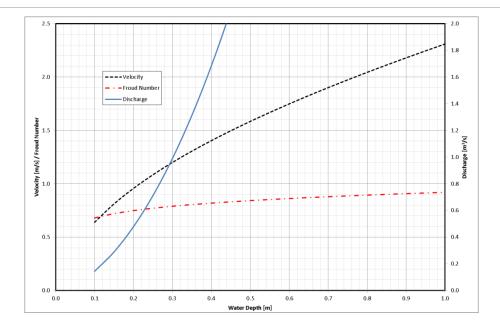
Figure 5.8: Hydraulic characteristics of the trapezoidal channel with a longitudinal slope of 0.005

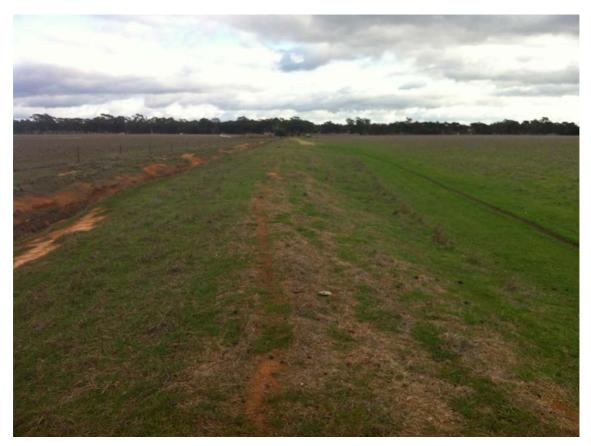
Figure 3. Existing drain, proposed for levee construction.

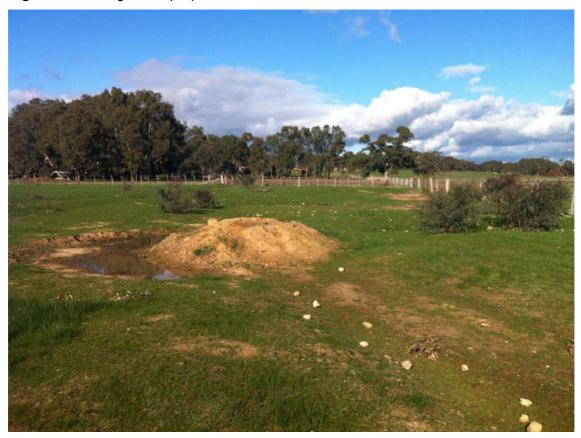
Figure 4. Existing drain, proposed for levee construction.

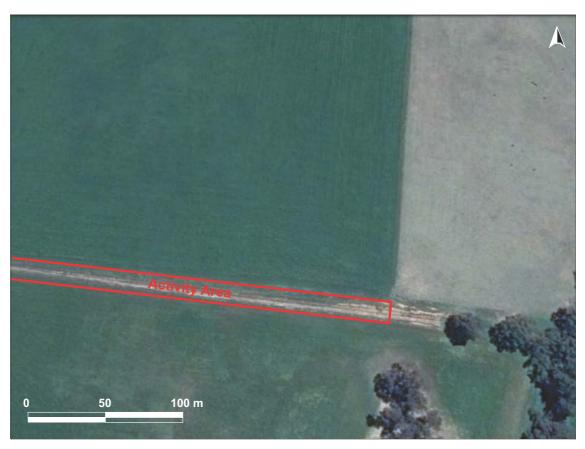
**Figure 5.** Aerial photograph of the section of the proposed infrastructure corridor within 200 m of McCallum Creek demonstrating the significant ground disturbance.

Common knowledge (Level 1) is not applicable in this case. Publicly available records (Level 2) in the form of an aerial photograph and expert advice (Level 4) based on the field investigation described in Section 4 (above) are instead used to establish that the section of the proposed infrastructure corridor within 200 m of McCallum Creek has been subject to significant ground disturbance. The aerial photograph in Figure 5 clearly shows the location of earthworks associated with past drain construction. These surface features clearly visible on a publicly available aerial photograph show that some corridor has been previous directly impacted by significant ground disturbance.

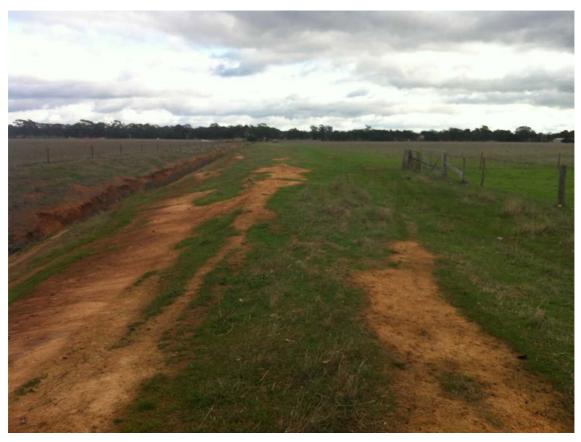
**Figure 6.** Section of the proposed infrastructure corridor within 200 m of McCallum Creek demonstrating the significant ground disturbance caused by drain construction.

The results of geomorphologist Dr Cupper's level 4 inquiry show that the corridor has been impacted by the use of light and heavy earthmoving machinery (Figures 6 and 7). This includes extensive excavations for a drain.

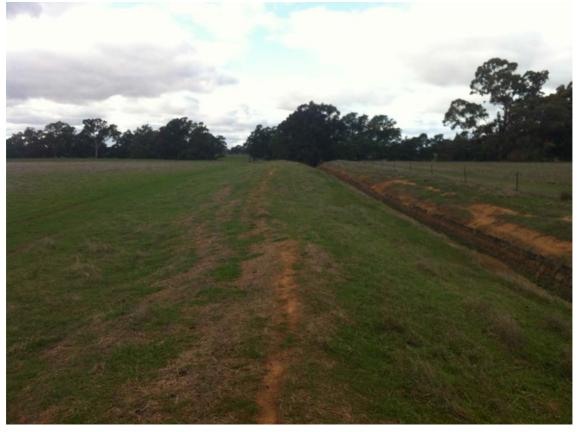
**Figure 7.** Section of the proposed infrastructure corridor within 200 m of McCallum Creek demonstrating the significant ground disturbance caused by drain construction.

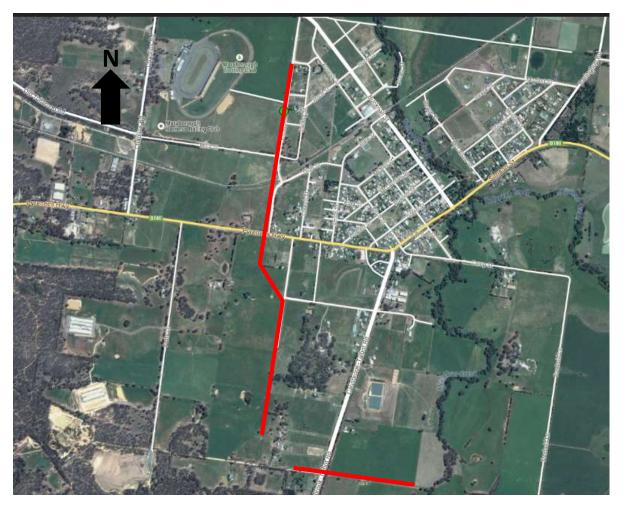
An aerial photograph of the township of Carisbrook has been sourced from the "Nearmap Online Aerial Photograph Site", see figure 1. The proposed levee alignments are shown in red.
